SITE ANALYSIS AND JUSTIFICATION

COLUMBIA COUNTY

TASK 3 AND 4 REPORT SUPPLEMENT-1

The Florida Department of Transportation FDOT Contract BDV32-945-001

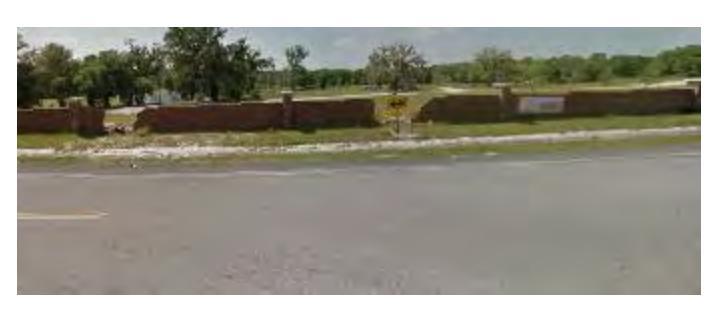
Figure 11. Damaged walls on west end of the intersection (Google Maps cache)

Table 4 lists the 20 historical crashes at this intersection between 2013 and 2017 with four injury and 16 PDO crashes. Seventeen of the 20 crashes occurred during dry conditions, and 12 of the 20 occurred during daylight conditions. Figure 13 shows the crash type by severity. At the intersection, there were one incapacitating injury crash, two non-incapacitating injury crashes, and one possible injury crash, along with 16 PDO crashes. Lane departure crashes included head on, sideswipe, off-road, and rollover crashes. There were three injury crashes and seven PDO lane departure crashes at this intersection, including four off-road, two head-on, and three rollover crashes. Two lane departure injury crashes that occurred in daylight conditions on the curve resulted in head-on collisions. There was one night-time PDO crash in which the vehicle was overturned on WB Deputy J Davis Lane curve. Another PDO rollover crash on WB Deputy J Davis Lane was animal related. One nighttime PDO rollover crash occurred on the NB CR-252B curve. At this intersection, three WB vehicles failed to stop and crashed into the wall on the west side of the intersection (Figure 11).

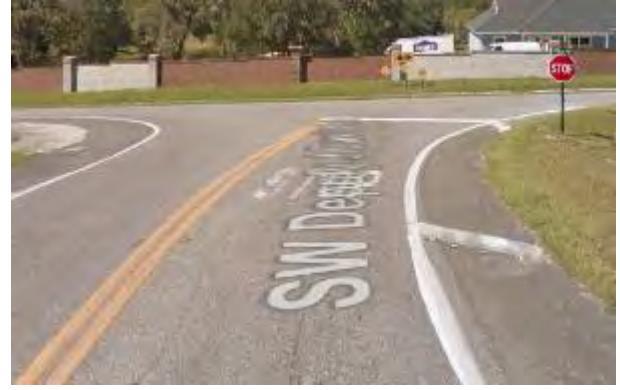
Figure 12. Replaced section of walls on the west end of the intersection

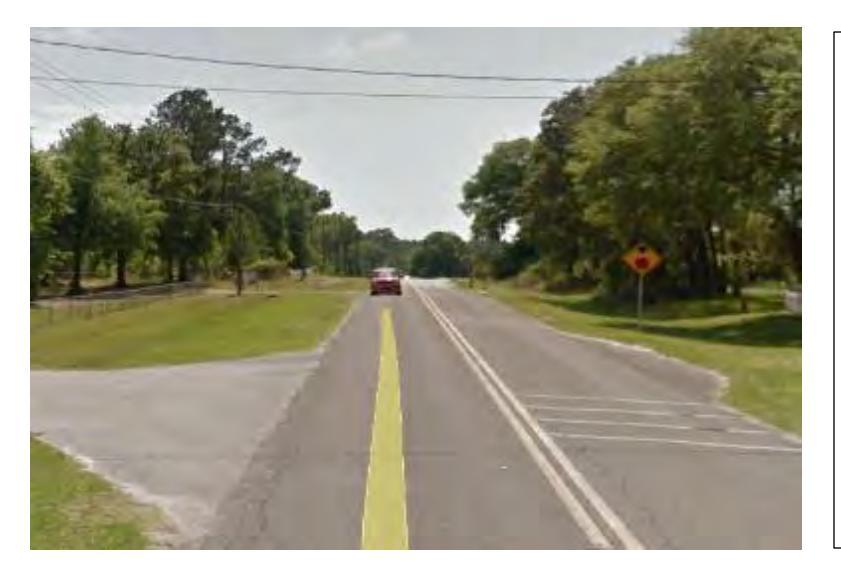
Figure 14. Deputy J Davis Ln – WB approach to curve obscured by hill

There is both a hill and a curve on the Deputy J Davis Ln WB approach to the intersection that limit the driver's view of the intersection. Although there are rumble strips and a "Stop Ahead" sign, the number of crashes involving vehicles that fail to stop suggests that additional measures are needed to alert the driver of the expected change in alignment. The problem seems to be exacerbated by the downhill grade of Deputy J Davis Ln on the WB approach to the intersection.

The hill on the approach to the curve on Deputy J Davis Ln limits the view of the curve for vehicles approaching from the east.

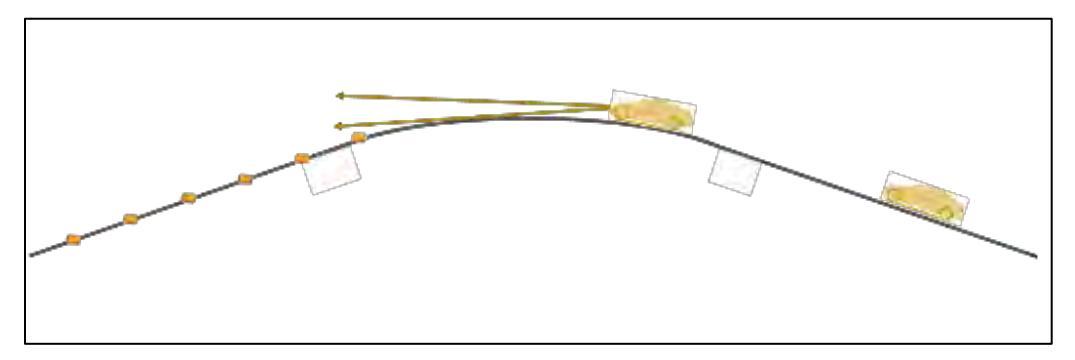
Figure 16. Traditional RPM functionality on a combination of vertical and horizontal curve

- Center- and edge-line IIRPM through length of Deputy J Davis Ln curve
 - Traditional RPM relies on reflecting the vehicle's headlight. This is while there is a vertical alignment before the horizontal curve on SW Deputy J Davis WB. In such conditions, it might be too late for the driver to realize the change in alignment, as shown in Figure 16.
- Centerline RPM on north leg

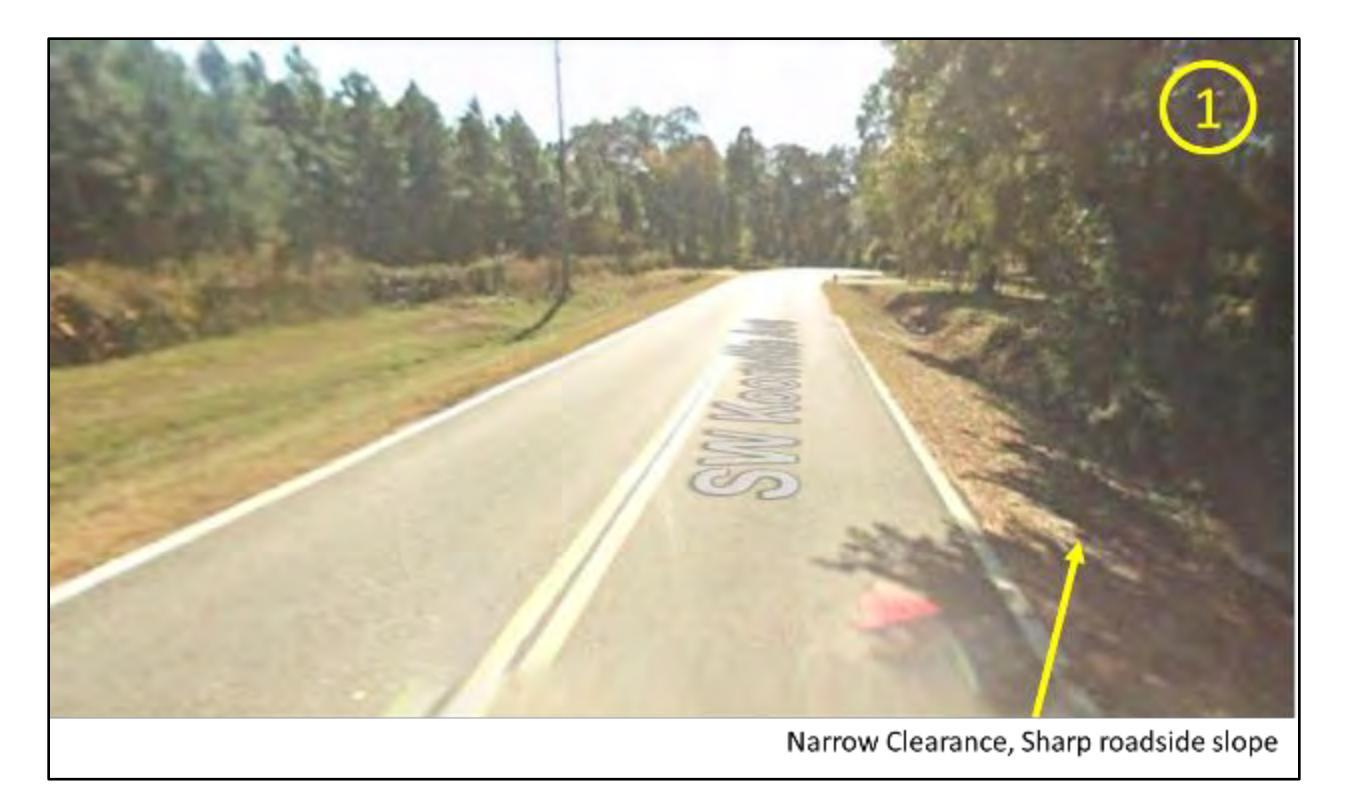
Figure 20. CR-252A curve #1, looking south

There were four nighttime curve-related crashes (one fatal, two injury, and one PDO). Field observation noted that there was no "Curve Ahead," chevron, or RPM for this curve. In addition. There is no paved shoulder for recovery, and one side of the curve has narrow clearance and sharp roadside slope (Figure 20 and Figure 21). Curve #1 has a small radius, with only 800 ft, and four of the crashes occurred on this curve. This curve is an ideal candidate for implementation of high-friction surface treatment (HFST) and internally illuminated RPM (IIRPM) because these measures can help the drivers decrease their speed effectively and negotiate the curve safely. All the crashes at curve #1 occurred SB with its downgrade curvature.

Field observation also noted that there were two chevrons on the wrong side of the road on curve #1, which we recommend be removed.

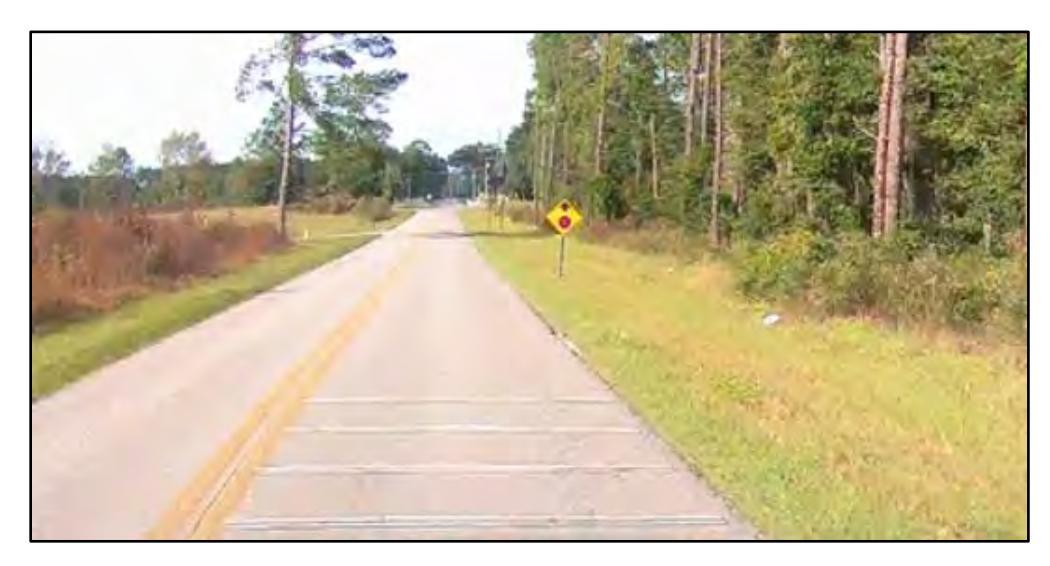
Figure 30. Rumble strips and Stop Ahead sign on Wester Rd (WB) on approach to SR-47 intersection

Rumble strips in approach to the intersection, as shown in Figure 30.

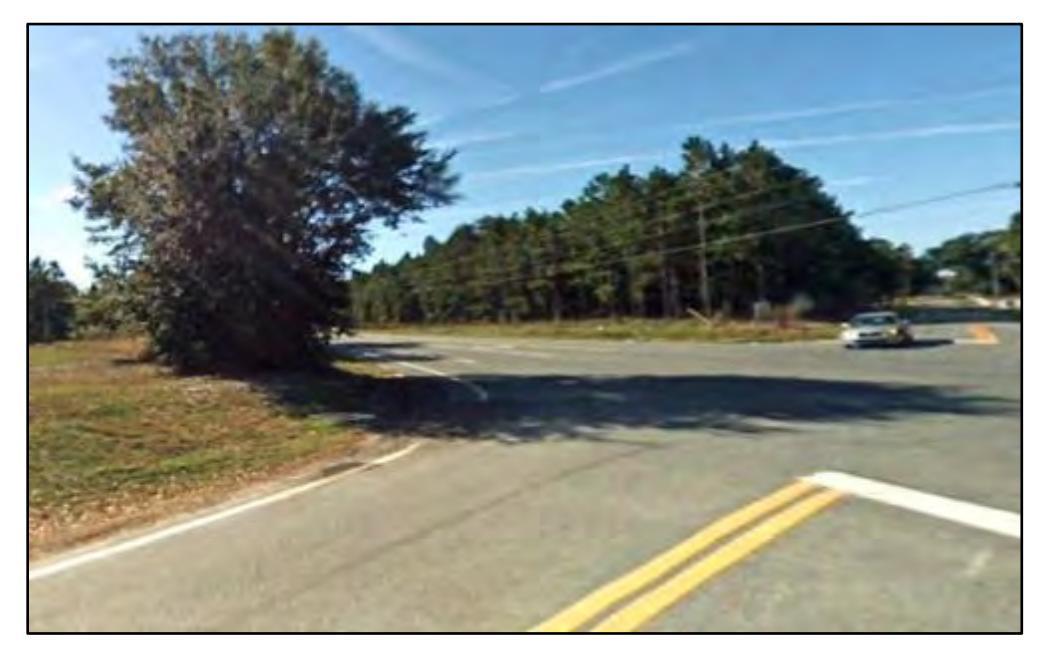
On the east leg of the intersection, the drivers' sight is limited for the south left turn due to the presence of trees (Figure 31). The WB minor road approach has a hill before the intersection that limits visibility between WB and NB vehicles.

Figure 31. Blocked sight distance Wester Rd WB, looking south

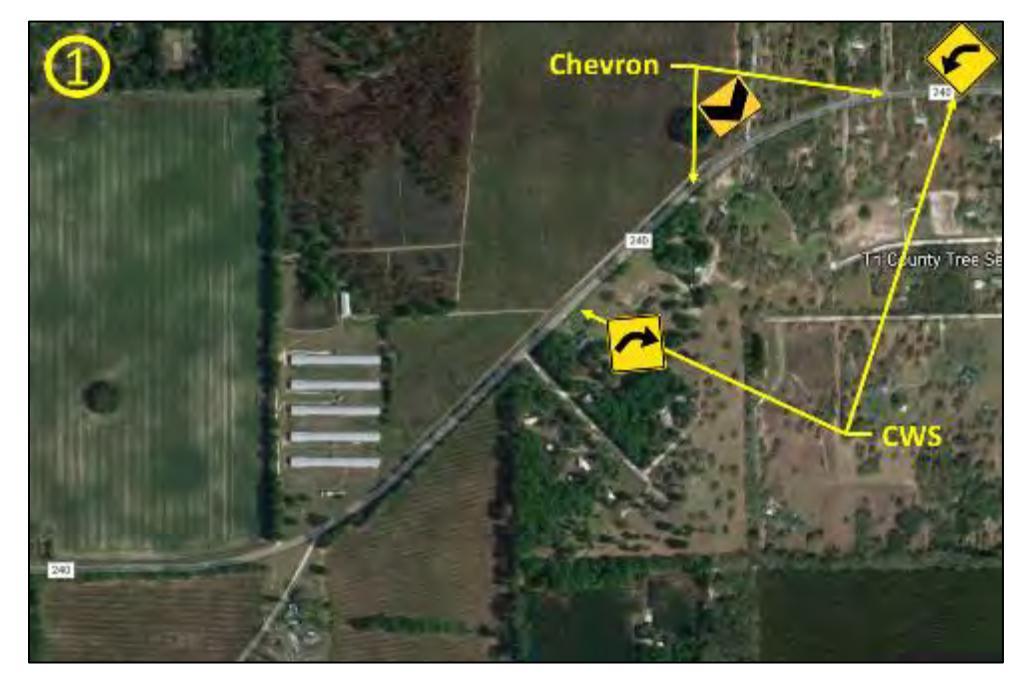
Figure 37. Existing condition on CR-240 site #1

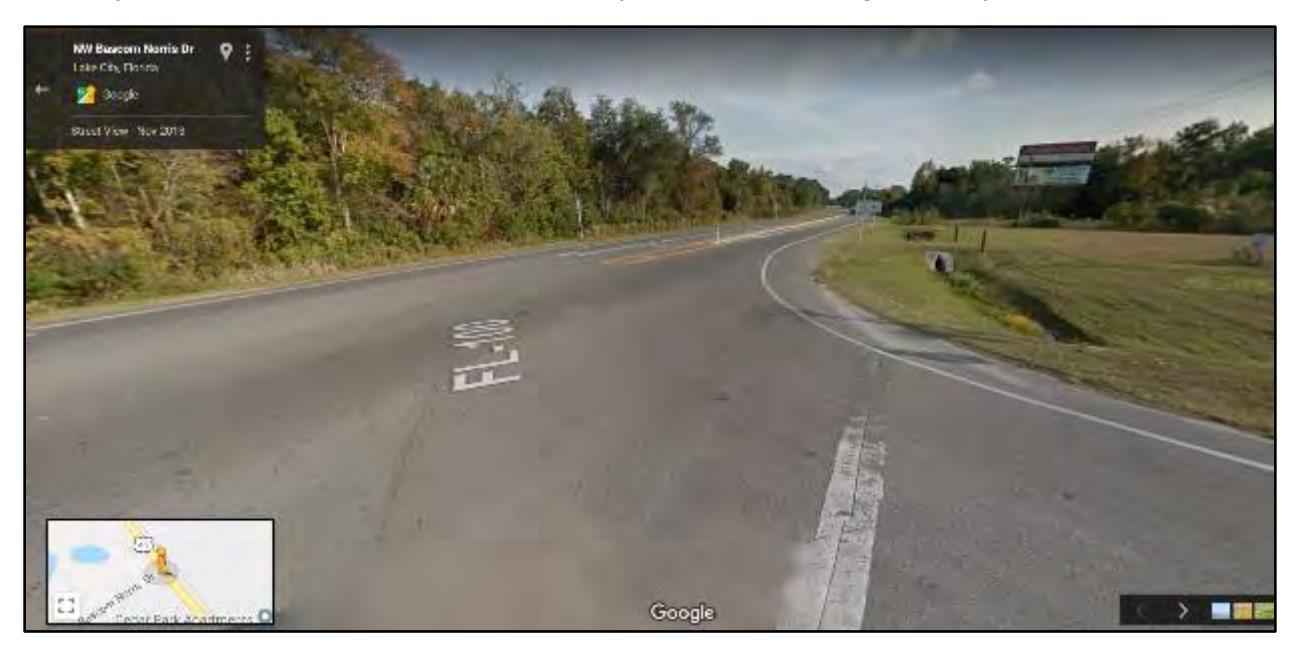
Figure 67 Blocking view problem on US-41 and NW Bascom Norris Dr

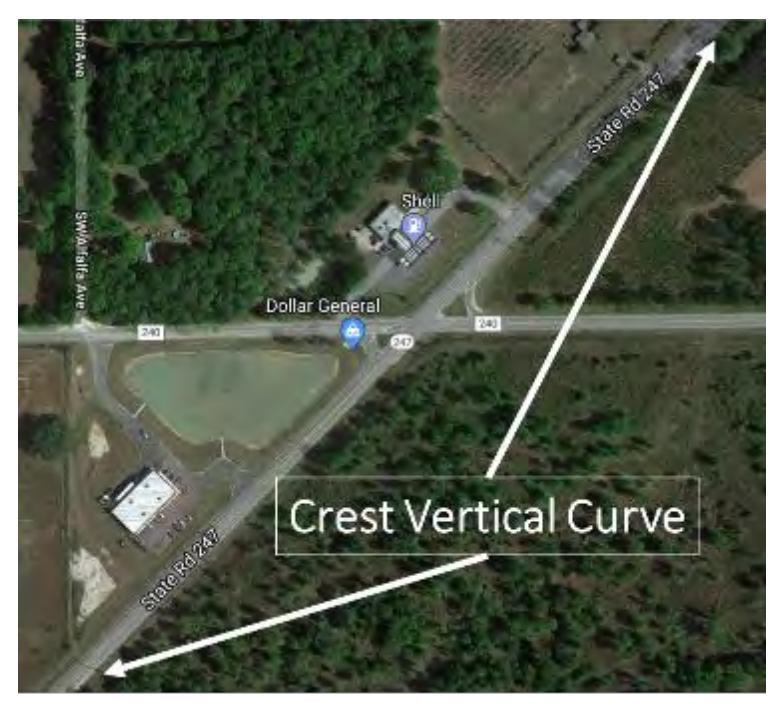
Figure 71. Visibility problem at CR-240 intersection
