Union County Site Analysis and Justification - CR229, CR241, CR18

*Safety Project Development Capacity for Small Communities
in Coordination with Local Technical Assistance Program (LTAP) Center*

REPORT

Prepared by:
University of Florida

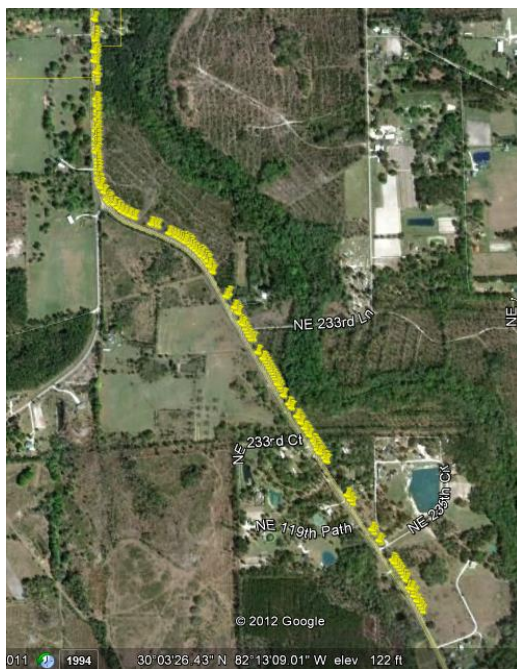
Figure 3. Pavement edge drop-offs on CR 229 (south)

Shoulders are generally narrow and provide limited recovery area. Pavement edge drop-offs are prevalent throughout the area. Figure 3 shows the extent of these drop-offs.

This aerial photograph shows the locations of pavement edge drop-offs as marked using a hand held gps device. The drop-offs were recorded while driving along the road in each direction of travel. Marks were recorded for each 25' of shoulder where the surface of the shoulder was estimated to be 3" or more below the pavement surface.

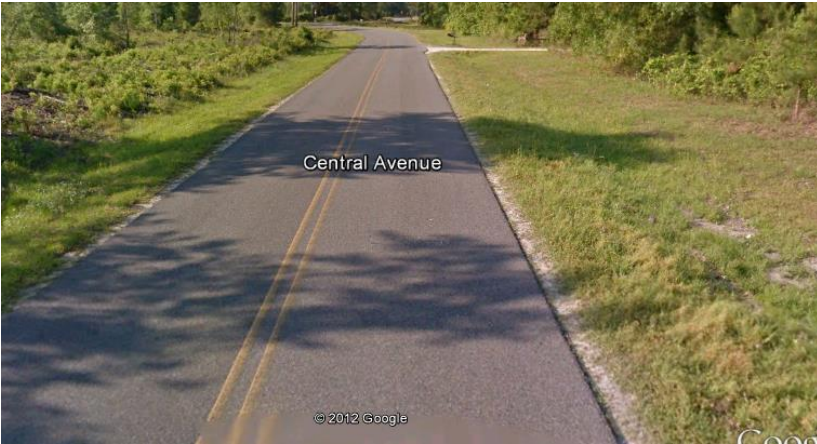
Figure 4. Typical shoulder conditions on CR 229 (south)

➤ Shoulders and Pavement edge drop-offs:

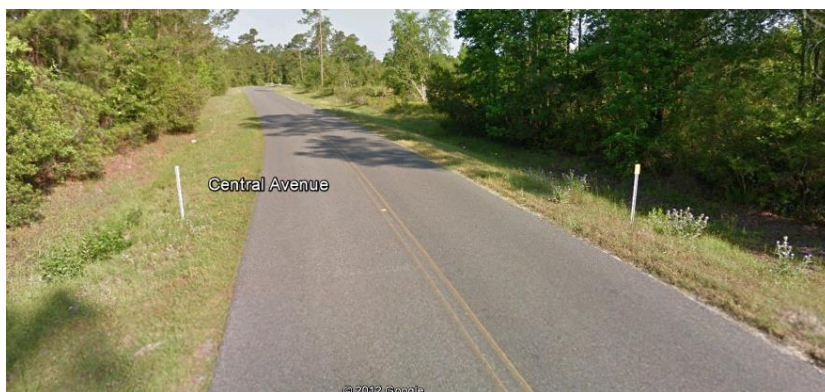
Figure 5. Culvert crossing (CR 229 south)

- **Culverts:** One culvert crosses CR 229 within the study area. Ends of this culvert are within the limits of the clear zone, and should be extended. The culvert at the intersection with CR 793 is within the clear zone for CR 793 (NE 227th Avenue). Culverts at NE 233rd Lane and at the various driveways all have blunt ends, but are small in diameter.

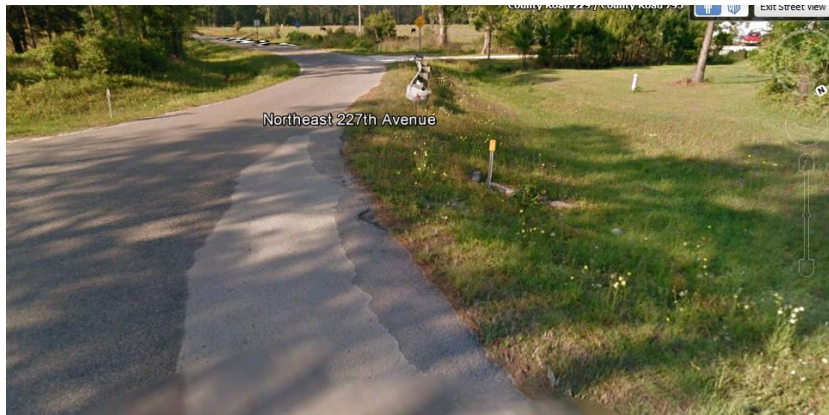
Figure 6. Culvert at CR 793 Intersection

- **Guardrail:** A guardrail along the west side of CR 793 (NE 227th Avenue) at the intersection with CR 229 shows evidence of a crash (Figure 6. Culvert at CR 793 Intersection). This guardrail could be eliminated by extending a culvert and flattening the slope of the shoulder; however, the guardrail now supports delineators that mark the outside of the curve of CR793. Removing the guardrail would require placement of alternate markings delineating the curve for northbound vehicles as they approach the intersection.
- **OTHER:** Right of way throughout the corridor is approximately 50 feet. Much of this right of way is clear, but trees encroach into the clear zone at some locations, especially on the east side of the road in the vicinity of NE 233rd Lane.

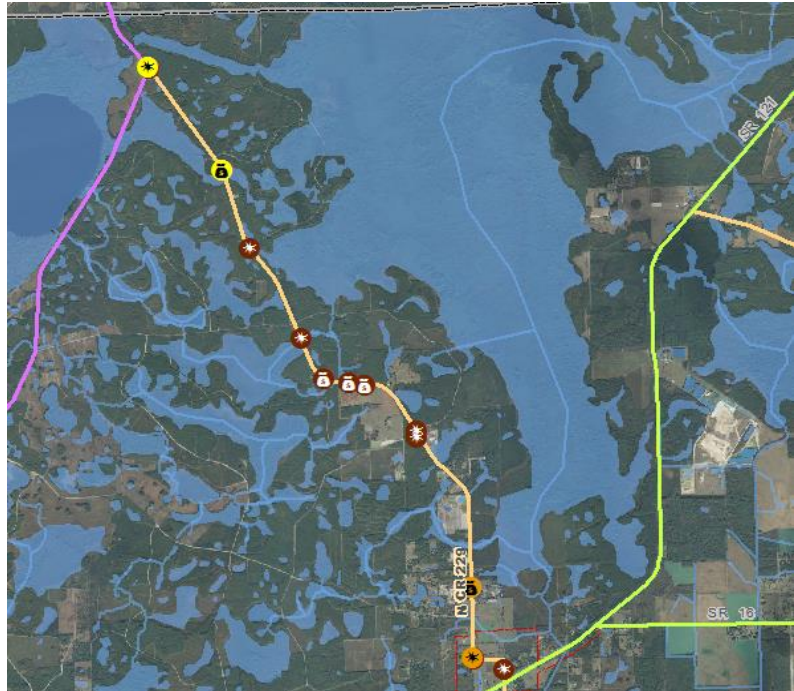
Figure 10. CR 229 north of SR 121 showing crash locations

One crash with a serious injury occurred when a vehicle approaching from an intersecting road failed to stop at the intersection. Three of the crashes occurred at the curve in the vicinity of NE 215th Road.

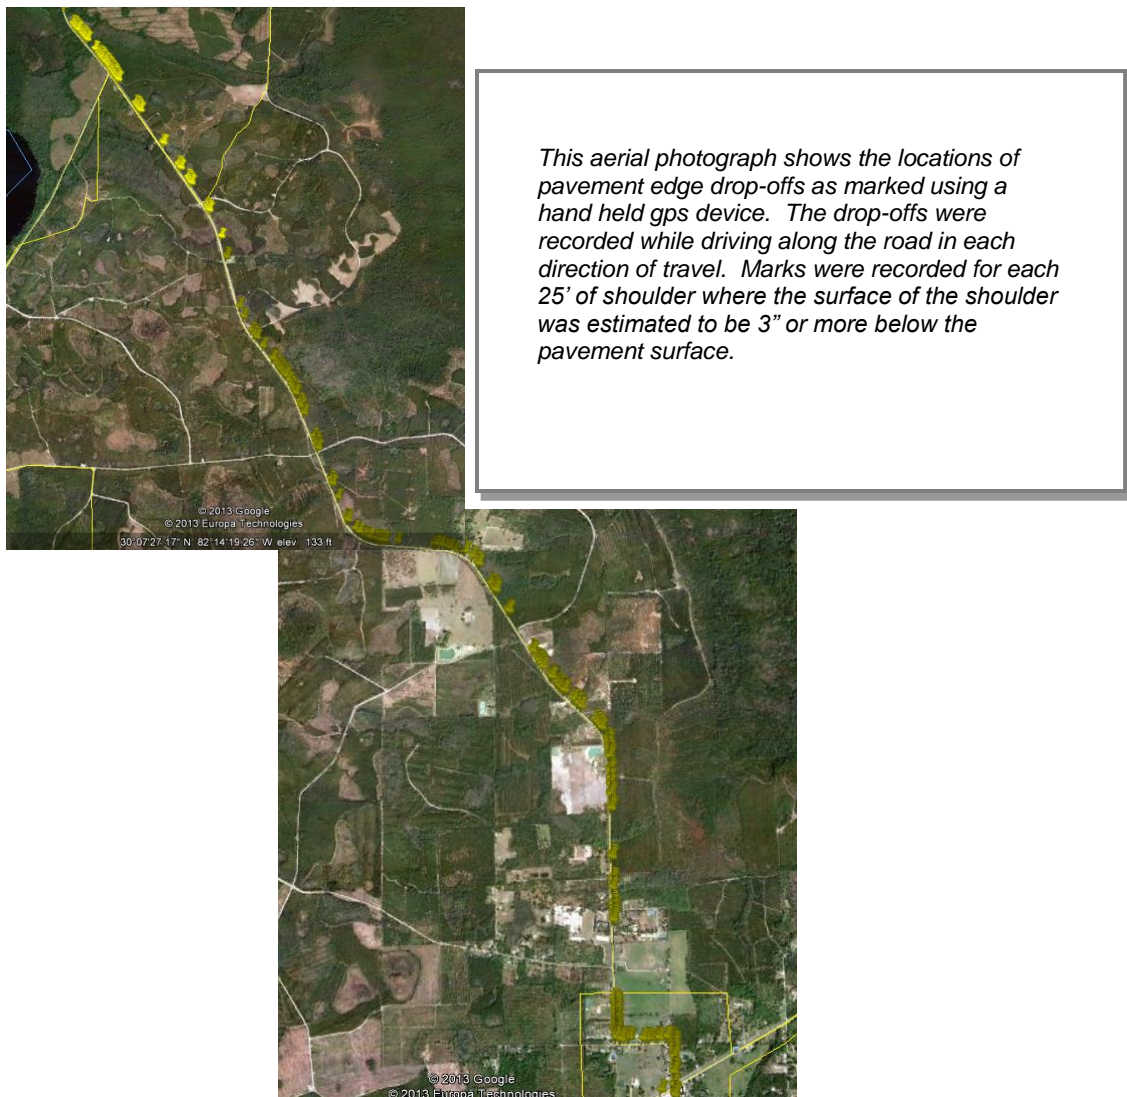
Figure 11. Pavement edge drop-offs (CR 229 north of SR 121)

The pavement is narrow, but it does not show significant signs of distress. Pavement edge drop-offs are extensive (See Figure 11). Shoulders are generally flat and clear through most of the corridor, but there are a few locations where the presence of a roadside ditch would make recovery difficult. Since the lane departure crashes occur mostly at night, it would appear that the problem is associated more with lack of lane delineation than with condition of the shoulder; however, improving the recovery area could be expected to reduce the severity of the lane departure crashes.

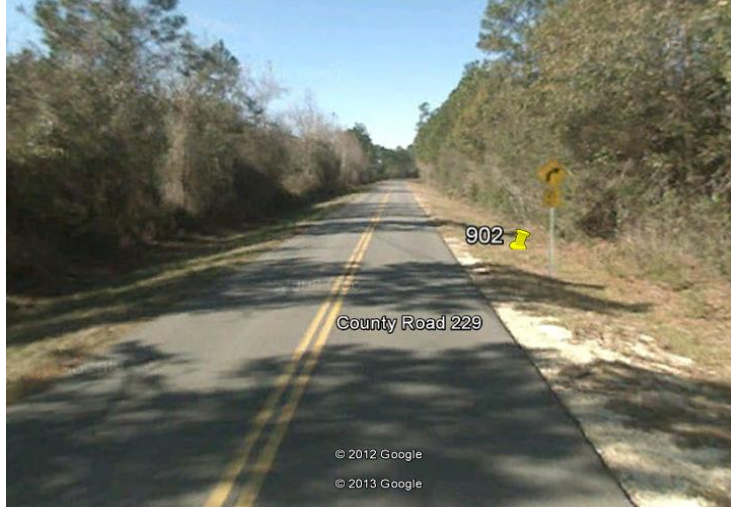
Figure 12. Typical curve warning sign (CR 229)

This sign is posted well in advance of the curve (approximately 600'). There are no chevrons, edge lines, or other markers to delineate the curve.

Moving the sign closer to the curve, delineating with chevrons and edge markings, and adding an advanced warning sign would help drivers identify the curve, especially at night.

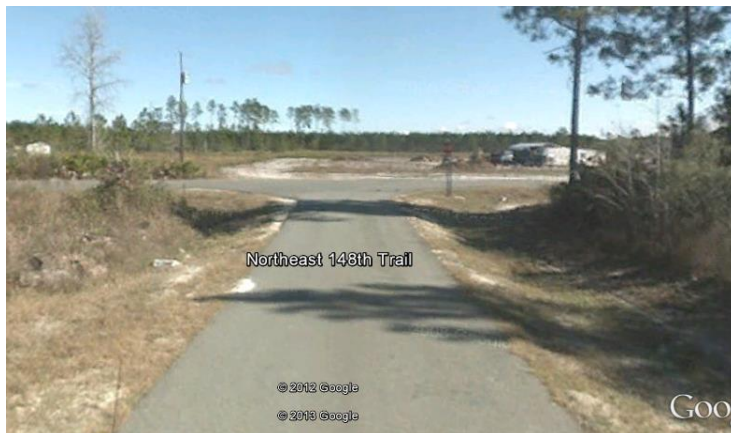
The intersection at NE 148th Trail was the site of a serious injury crash involving a vehicle that failed to stop.

Increasing the size of the stop sign, adding a double arrow and stop bar would improve communication to the driver about the stop condition.

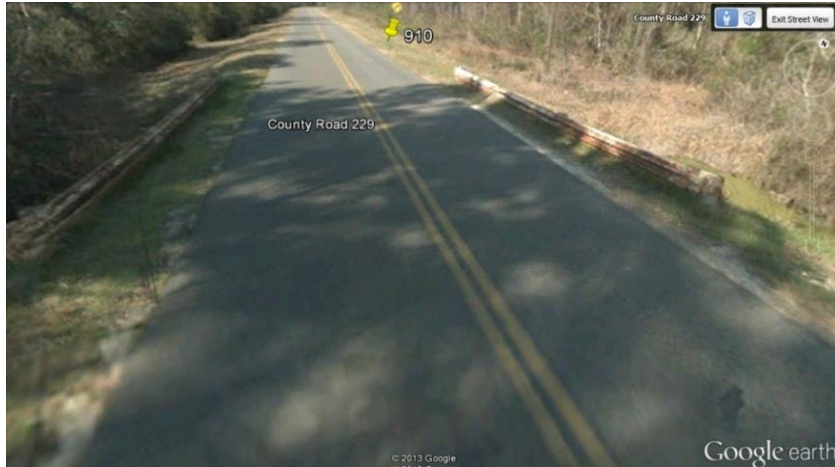
Figure 14. Typical guardrail installation (CR 229)

Guardrail installations are obsolete, although no involvement was reported with any of the crashes reviewed.

- Improve night time visibility of the pavement edge, especially through the curves.
- Upgrade end of road signage and markings at intersections.
- Improve recovery area:
 - Replace obsolete guardrail and extend guardrail to cover unprotected areas.
 - Widen pavement and add paved shoulders to correct drop-offs, especially through curve.

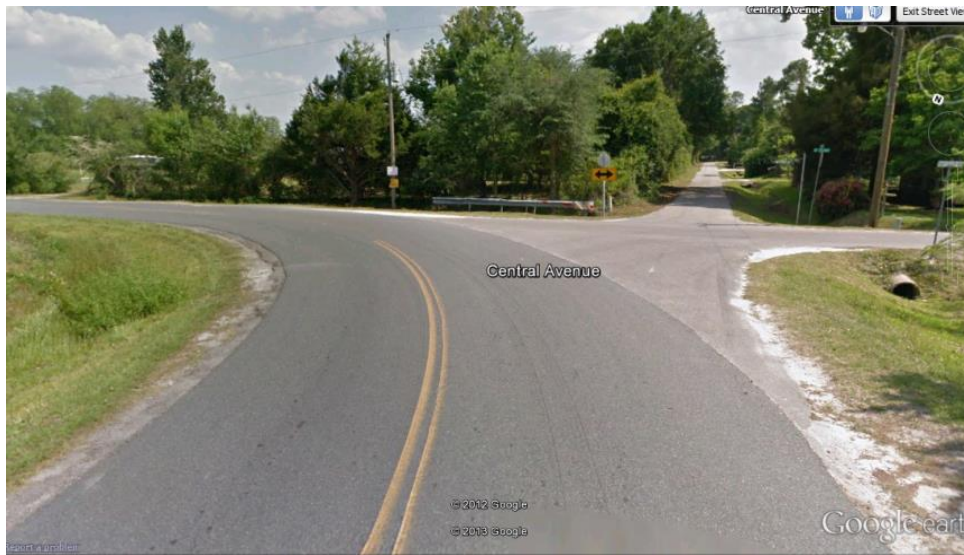
Figure 16. Southbound view of guardrail and exposed culvert end at NE 228th PL/NE 125th Way

The conditions at this location do not appear to be a serious concern, although there is erosion of the shoulder on the inside of the curve. Roadside ditches on the west and south sides of CR 229 pose potential problems. A guardrail along the south edge of CR 229 does not completely shield a ditch and power pole. The end of the culvert under the west leg of the intersection has a vertical end exposed to southbound traffic.

Generally, upgrading signs and markings could improve delineation of the intersection (Figure 16 and Figure 17). There is no turn sign delineating the west to north movement. A stop sign on northbound leg of intersection is partially obstructed by vegetation. An advanced warning sign ("Dangerous Intersection") is in place on the southbound approach to the intersection.

<i>Level</i>	<i>Countermeasure</i>	<i>Estimated Cost</i>	<i>Benefit/Cost</i>
1.	<ul style="list-style-type: none">• Upgrade signs delineating turn for SB/EB traffic – including upgrade of advanced warning signs.• Add chevrons for southbound and westbound approaches.• Install sign delineating turn for WB/NB traffic – including advanced warning signs• Replace “Dangerous Intersection “ sign with alternate treatment for enhanced conspicuity.• Add left side stop sign for north bound 228th Place where vegetation obscures signs during growing season.• Refresh pavement markings and add RPMs and edge lines. (Since approach speed for southbound vehicles is an apparent problem, add speed reduction markings as described in MUTCD Section 3B.22.)• Upgrade and extend guardrail on south side of CR 229 to shield fixed objects and ditch.• Add mitered end sections to culvert under west leg of intersection.	\$22,842	37.73

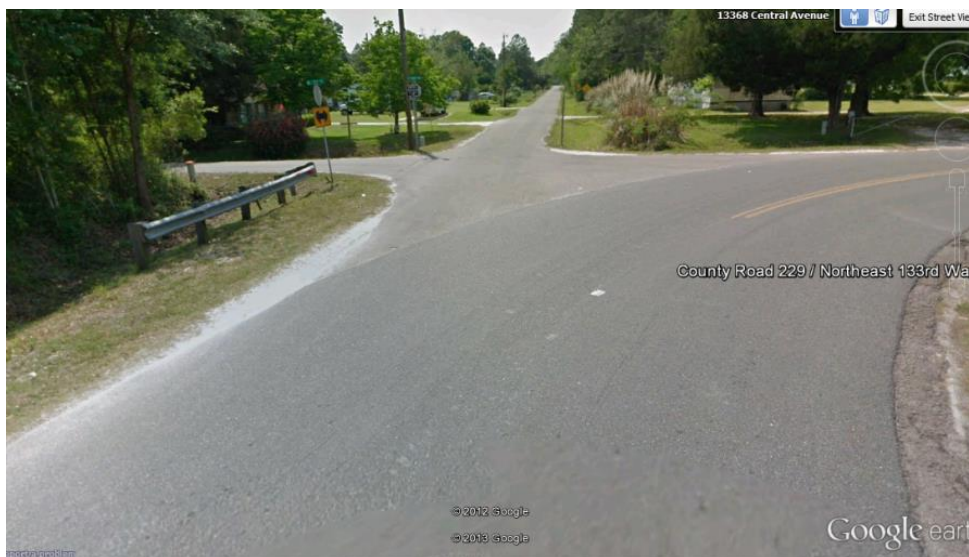
Figure 17. Westbound view showing lack of signage delineating turn at NE 228th Place/NE 125th Way

The centerline pavement markings are worn, and there are no pavement edge markings.

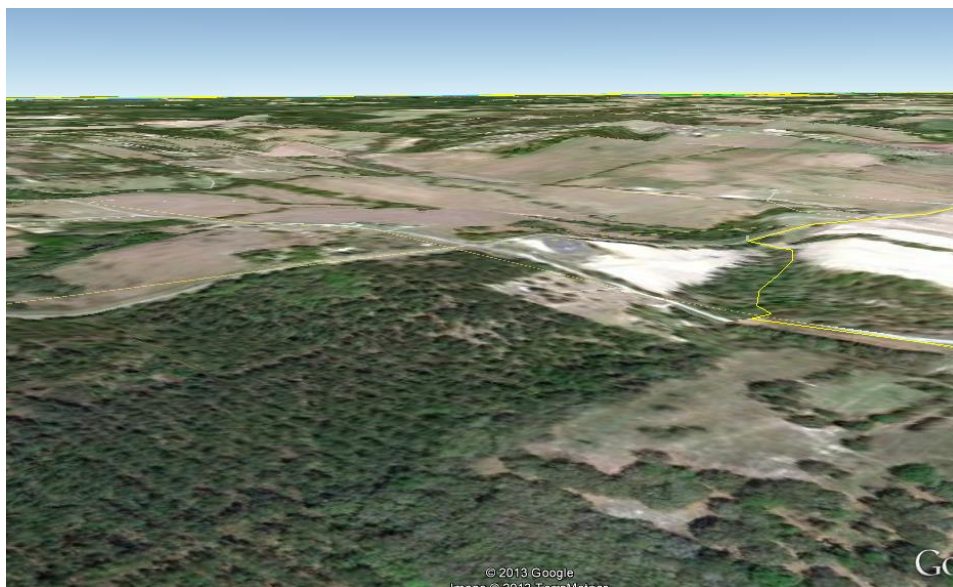
Figure 21. Topography of intersection CR 241/18 (vertical scale exaggerated)

Visibility of the intersection and stop signs is restricted and may have been a contributing factor in the three most serious crashes. The intersection is situated on a small “plateau” at the top of the hill and the roadway surface is hidden from view on all four approaches by the vertical curvature of the road (Figure 21 and Figure 22).

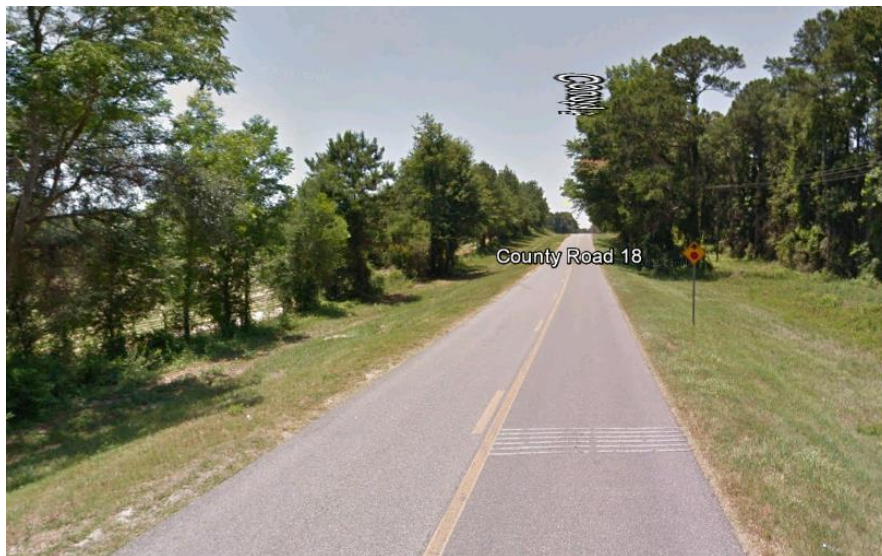
Figure 22. Advanced intersection warning (westbound approach to CR 18/241 intersection)

Although stop signs and advanced warning signs are in place, the stop signs are partially obscured by the roadway grade. At the time of the field investigation, some of the signs were partially obscured by vegetation, but this has been subsequently trimmed by Union County crews. Union County does not have a bucket truck and has difficulty trimming trees that overhang the road or the clear zone. This can create a serious problem where overhanging limbs create a canopy that limits visibility of the intersection or signs. Trees should also be reviewed to determine whether clear zone encroachment requires removal.

Rumble strips provide an audible warning but are not differentiated by color from the pavement so they do not provide a visual warning at night. Since the initial field investigation, the centerline and stop bars have been repainted.

<i>Level</i>	<i>Countermeasure</i>	<i>Estimated Cost</i>	<i>Benefit/Cost</i>
1.	<ul style="list-style-type: none"> • Upgrade signs and pavement markings. • Install stop signs and advanced warnings signs on both sides of road – each approach. • Install retro reflective strips on sign posts for enhanced conspicuity as described in MUTCD (Section 2A.15). • Replace or augment asphalt rumble strips with retro reflective material to provide increased nighttime visibility. 	\$19,144	41.51
2.	<ul style="list-style-type: none"> • All level 1 improvements. • Install overhead flashing signal; if conflicts with power lines prohibit overhead signal use flashers on advanced warning signs. • Install flashers on advanced warning signs as a temporary measure until overhead flasher can be installed. • Install luminaires on signal poles (if overhead flasher is feasible) 	\$83,791	20.29

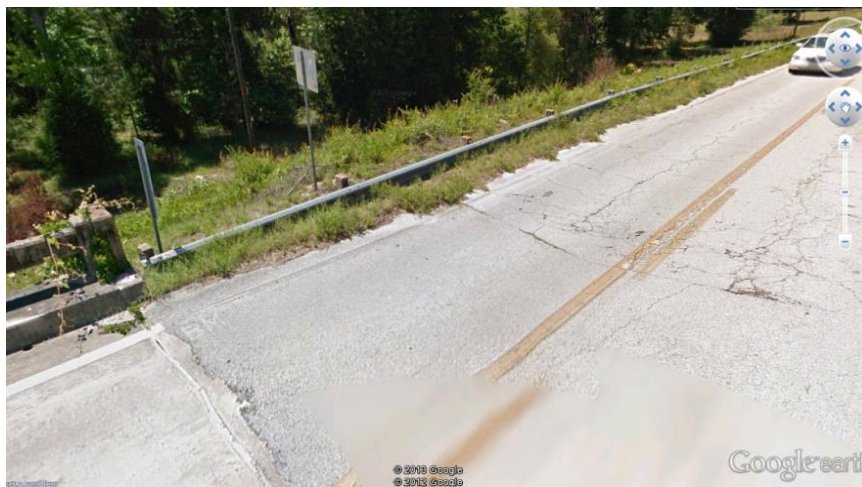
Figure 24. Guardrail at CR 241 approach to Santa Fe River Bridge

Although the guardrail appears to have prevented both of these crashes from becoming catastrophic, the guardrail installation is obsolete, in seriously deteriorated condition, and has gaps where critical protection is not provided. In its present condition it cannot provide the level of protection needed at this location.

- Upgrade guardrail.
- Improve shoulders. Pavement is deteriorated and any widening or shoulder paving should also be accompanied by restoration of the existing pavement.

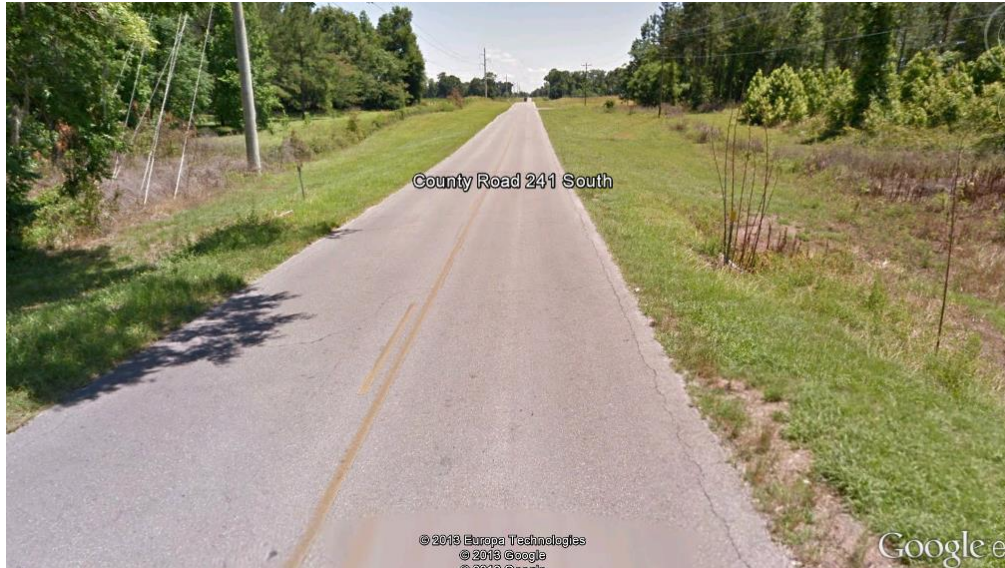
Figure 25. Culvert crossing with headwall in clear zone (CR 241 north of CR 18)

There is at least one culvert crossing without standard end treatments or guardrail protection (Figure 25). Driveway culverts generally do not have mitered end sections.

<i>Level</i>	<i>Countermeasure</i>	<i>Estimated Cost</i>	<i>Benefit/Cost</i>
1.	<ul style="list-style-type: none"> • Upgrade signs and pavement markings (Alachua County Line to CR 238). • Upgrade end of road treatments at “T” intersections. (Alachua County Line to CR 238). • Add signs designating areas where road is subject to flooding • Replace and add guardrail: <ul style="list-style-type: none"> ○ The main area of concern is the high fill section at the approach to the Santa Fe River Bridge. ○ Sites north of CR 18 need new installations. 	\$182,442	1.88

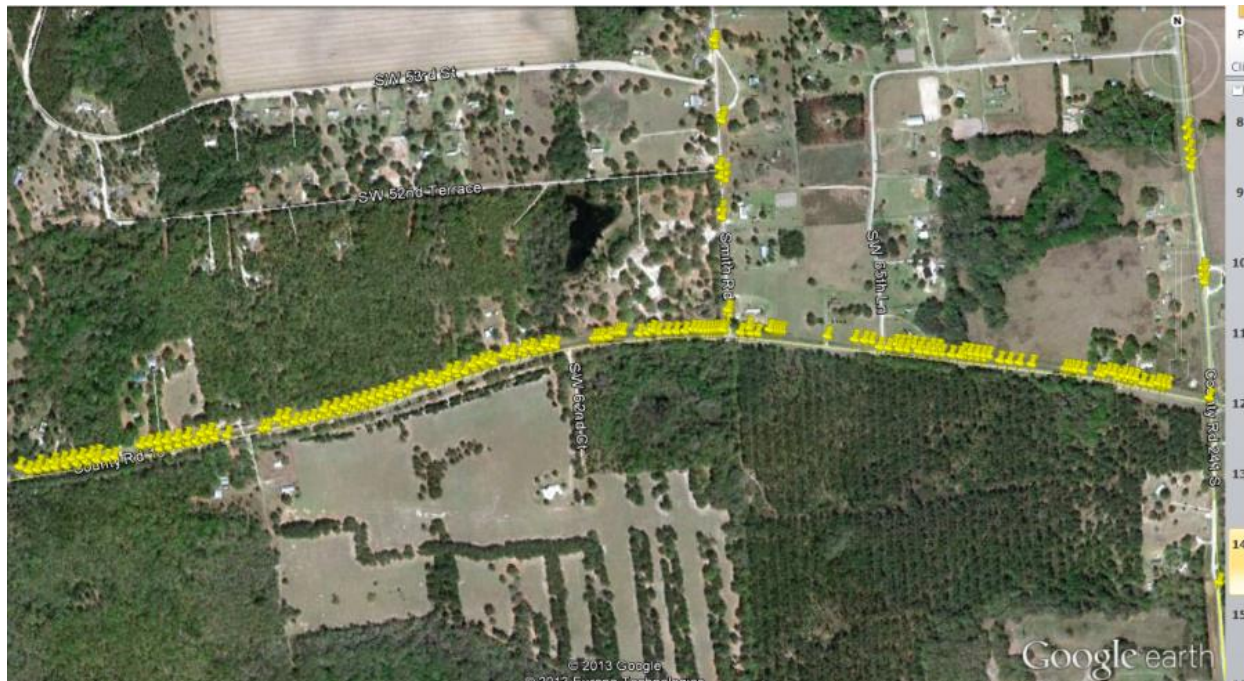
Figure 26. Drop-offs (CR 18 west of CR 241)

Pavement width is approximately 20 feet, with no significant distress noted. Pavement edge drop-offs are extensive throughout this section.

For the areas along CR 18, there are several locations where the recovery area involves steep slopes and/or trees are in close proximity to the travel lane.

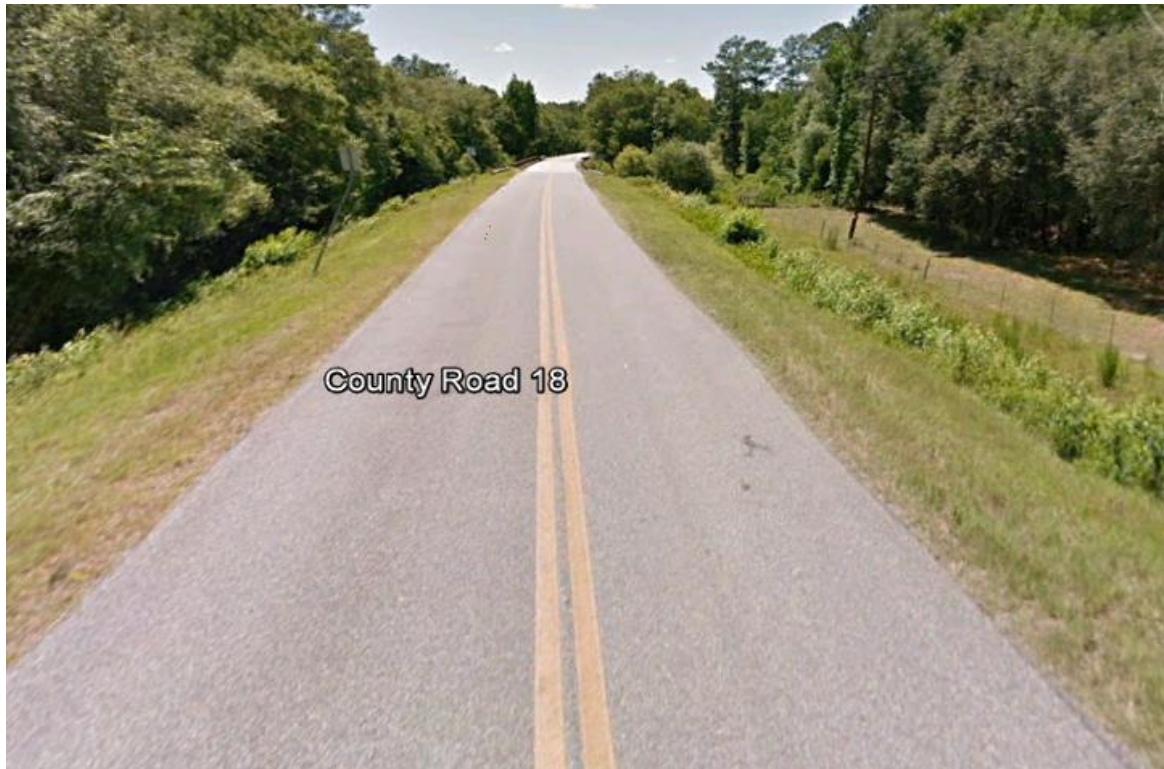
Figure 27. Unprotected slopes on approach to bridge at Columbia County Line

The approach to the bridge at the Columbia County line has a long fill with steep slopes. A short guardrail at the bridge does not extend far enough to provide full protection and end treatments are not consistent with current standards.

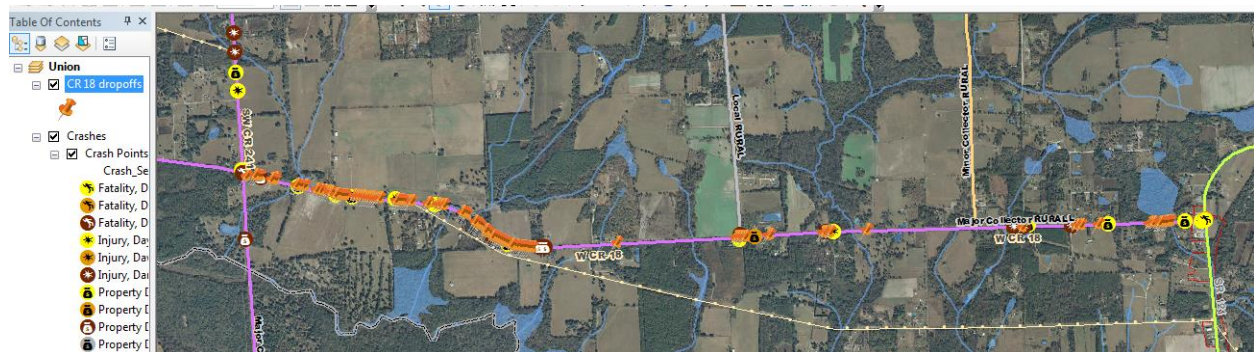
Figure 28. Drop-offs and crash sites (CR 18 from CR 241 to SR 121)

Pavement is narrow (approximately 20') and there are numerous locations where the shoulder is narrow and slopes are steep. Pavement edge drop-offs are a chronic problem. The graphic in Figure 28 indicate that most of the crashes occurred in areas with significant drop-offs.

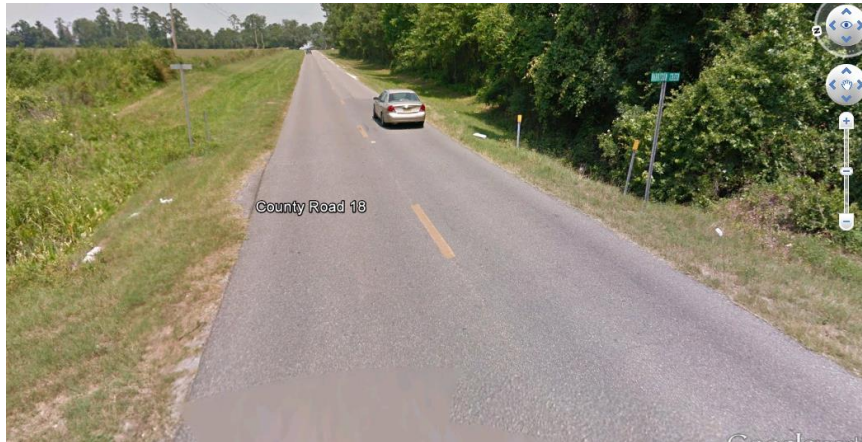
Figure 29. Culvert crossing and steep shoulder slope (CR 18 east of CR 241) without guardrail

Shoulders are generally narrow at culvert crossings and there are exposed headwalls or vertical drop-offs within the clear zone. Culverts at driveways and intersections do not usually include mitered end sections. Few locations have guardrail, and these installations generally do not meet current standards.

- Replace obsolete or substandard guardrail with appropriate installations; add guardrail where needed.
- Eliminate or shield non-conforming features within the clear zone (culvert ends, steep slopes, trees).
- Eliminate or reduce pavement edge drop-offs (paved shoulders):
The most severe problem with pavement edge drop-offs and the highest incidence of crashes occurs between CR 241 and SW 95th Lane (Figure 28). (The alignment of the road has two significant curves, but the existing slopes and right of way would appear to make shoulder construction in this area less costly and simpler than in other segments of the corridor.)

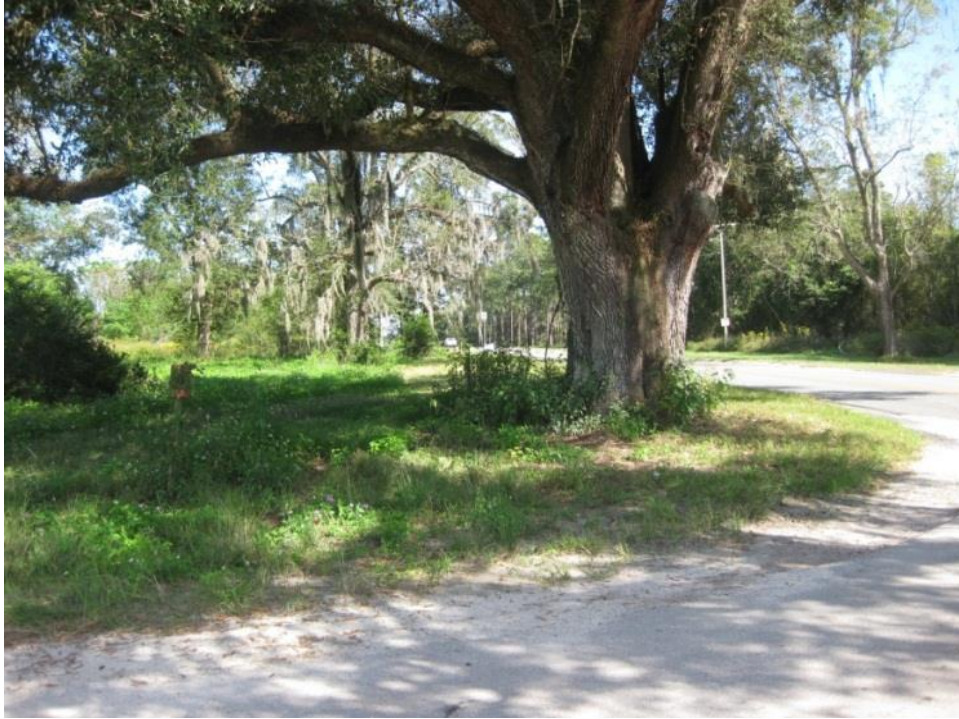
Figure 31. Restricted sight distance at intersection (CR 239 and SW 111 Lane)

Three of the crashes involved vehicles entering CR 18 from intersecting roads (CR 239 and SW 111 Lane). Two of these three were at night. In one case, the investigating officer identified vegetation that obstructed the vision between the vehicle approaching the intersection and oncoming traffic.
