# **SITE ANALYSIS AND JUSTIFICATION**

## **HENDRY COUNTY**

*Safety Project: Implementing a Transportation Safety Center (TSC) through Florida Local  
Technical Assistance Program (LTAP)*

*University of Florida*

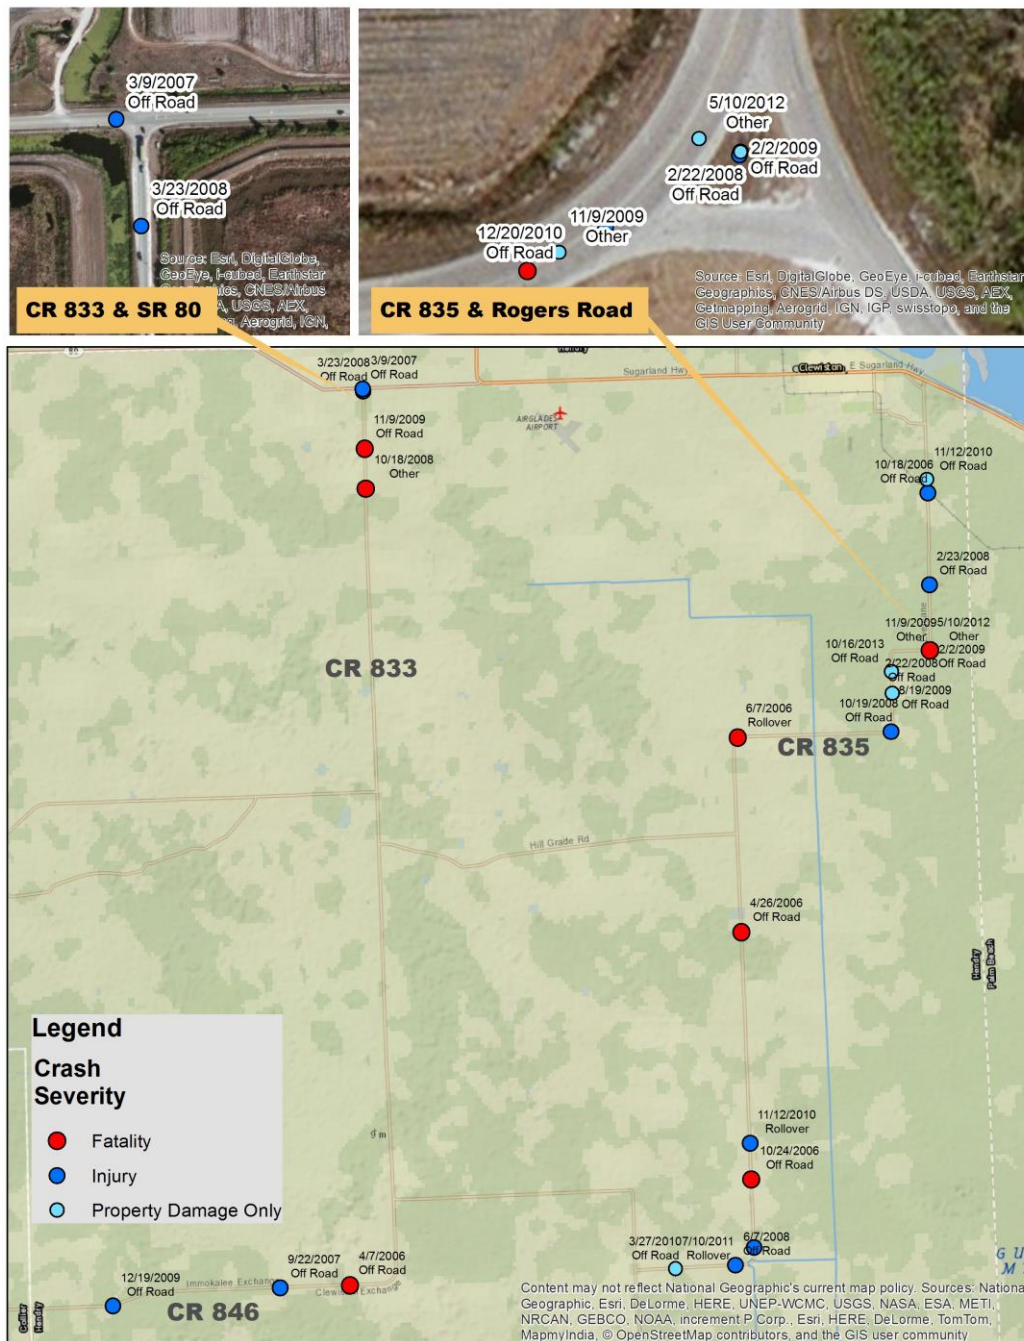
The crash summary in Table 4 shows that of the off-road/rollover crashes, 29 of 49 crashes involved vehicles entering a canal. Seven of thirteen fatalities in the study area involved vehicles entering a canal. Figure 5 shows these crash locations.

Figure 5 Crashes where vehicle entered a canal

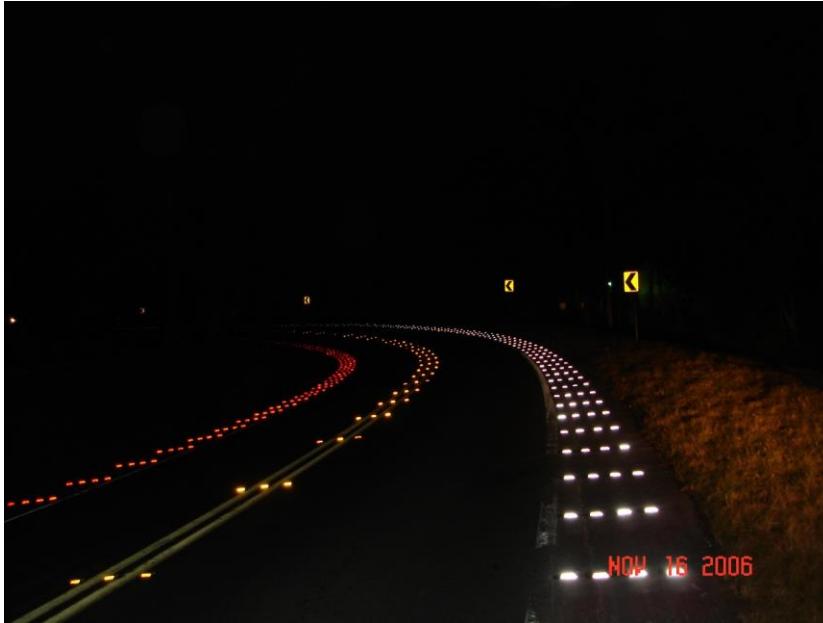
This photograph illustrates how pavement markings, including raised pavement markers can be used to enhance the nighttime visibility of a curve.

**Figure 9 Enhancement of nighttime visibility of a curve using raised pavement markers on shoulders**

- Supplemental RPMs and chevron stripes on shoulders through curves and approaches. This treatment, especially on the outside of the curve, can be especially effective in providing nighttime delineation of the pavement and alerting the driver to the change in alignment. Placement of the ground in place rumble stripe at the lane line should help reduce the traffic over the RPMs.

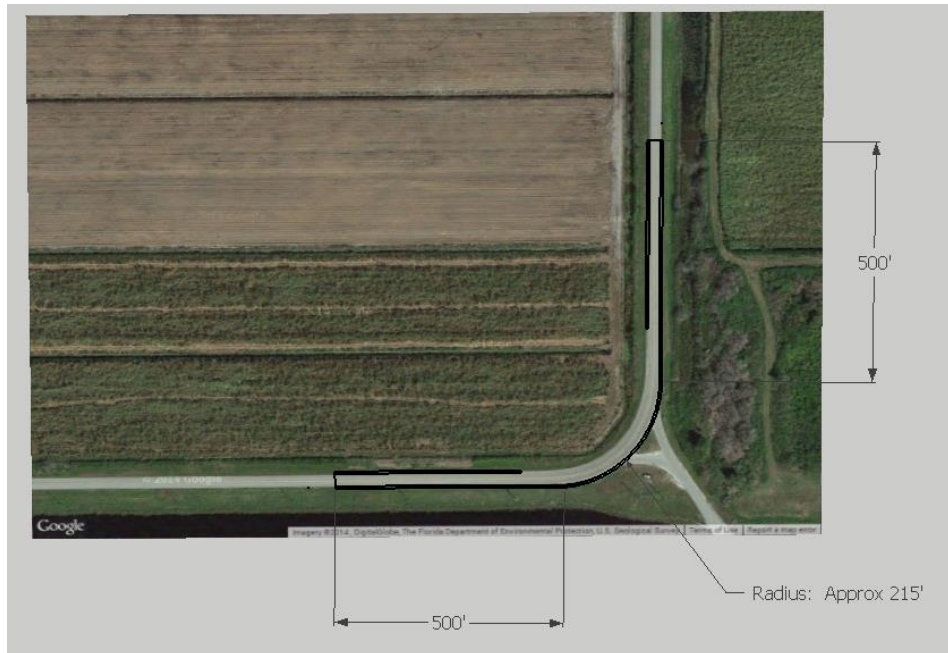
Figure 10 Recommended shoulder paving at curves

- Add paved shoulder throughout curve and approaches as shown in Figure 10. In some cases, right of way or presence of ditches may limit the widening. At a minimum, the pavement should be 22 feet plus three feet for shoulders. Extend this cross section 500 feet in each direction from the PC and PT of the curve. (For most of the curves, the inside shoulder has been paved, but for the purposes of cost estimates it, is assumed the shoulder will be repaved throughout the entire length of the curve.)
- Use safety edge for all shoulder paving. ( Figure 11)
- For pavement markings on the shoulder, use diagonal markings similar to the markings now in place on the inside paved shoulders at curves. Space these markings at 20 feet, and extend the pattern for the full length of the paved shoulder. Supplement the diagonal stripes with RPMs.

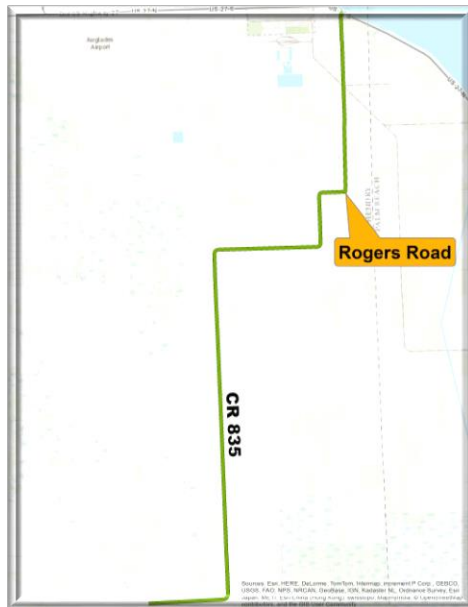
Figure 12 CR 835 at Rogers Road

This curve has the most serious crash record of all locations reviewed. It has a posted advisory speed of 25 mph. Concerns at this location include:

- A large canal is located along the southern limits of the curve/intersection.
- The southbound approach is a long tangent through agricultural lands with a uniform appearance. There are few visual cues that the alignment changes abruptly, especially at night.
- Poles for a major power line along the south edge of the CR 835 right of way represent fixed obstacles. While they are outside the clear zone these have been struck by vehicles that failed to negotiate the turn. There is a short section of guardrail parallel to the canal, but it provides little opportunity to redirect a southbound vehicle.

Twelve crashes were reported at this location. Ten of these involved vehicles that entered the canal, most from the southbound direction. One of these was fatal. Ten of the twelve crashes were in non-daylight conditions.

- Upgrade signs and pavement markings; pave shoulders (included in recommendations for all major curves).
- Install advanced warning beacons on southbound and eastbound approaches to the curve.
- Install luminaires. Illumination of the area around a curve will alert the driver well in advance that there is a change in the features of the road and will provide positive assistance in helping identify the changes in the configuration. This is a critical feature for this location since most of the crashes occur at night. (Electrical service appears to be available at this location.).

- Install guardrail, cable, or other positive barrier to redirect southbound vehicles that fail to negotiate the curve to prevent them from entering the canal.

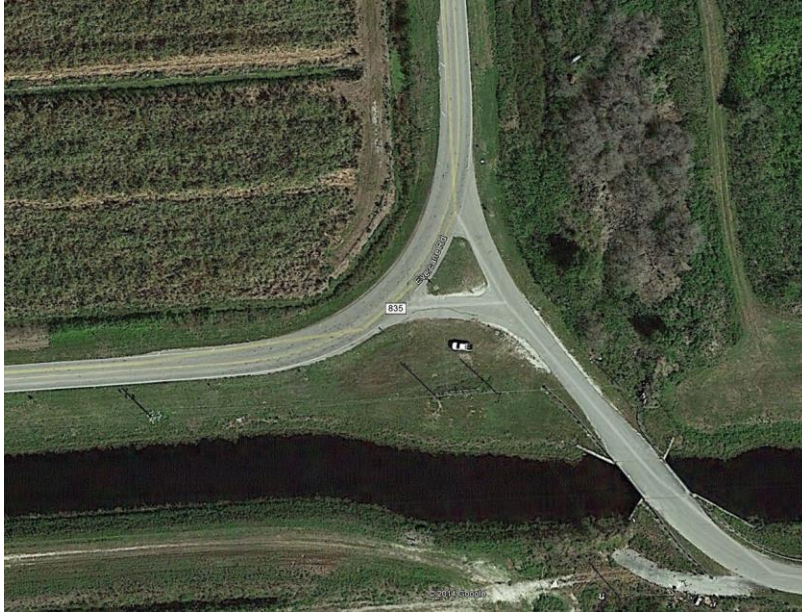
**Figure 13 Aerial view of CR 835 at Rogers Road**

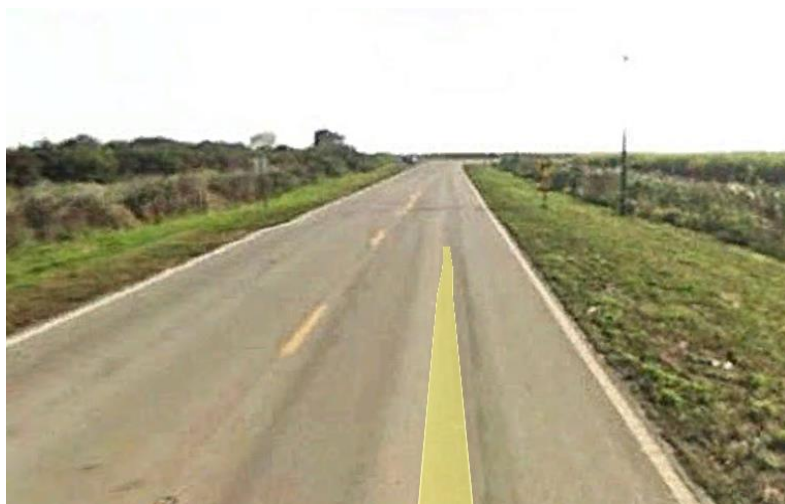
In this daytime photograph of the Rogers Road approach, the curve is more discernible, but the absence of other visual cues could make it difficult for an inattentive driver to slow adequately to negotiate the curve at a safe speed.

**Figure 15** Daytime view at southbound approach to curve at Rogers Road intersection (from Google Street View)

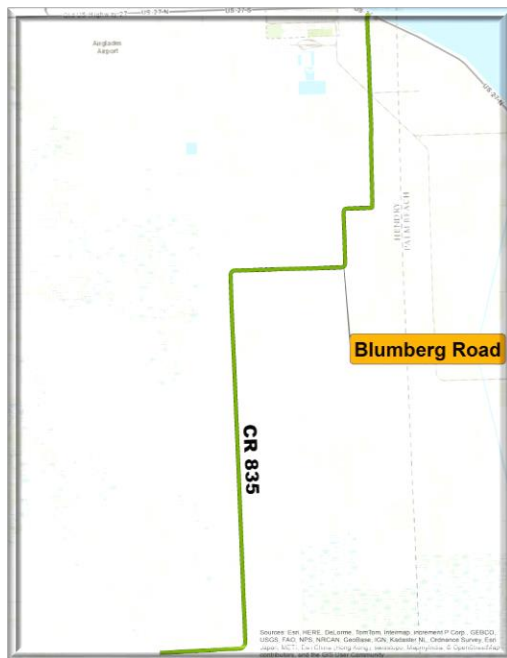
**Figure 17 CR 835 at Blumberg Road**

Blumberg Road intersects CR 835 near the midpoint of a curve. A substantial canal runs along the outside radius of the curve (Figure 18). Only the inside shoulder is paved. Some pavement edge drop-offs were noted on the outside pavement edge, and the outside shoulder slopes sharply toward the canal

Signs have been recently upgraded, but pavement markings are worn. The primary concern at this location is that vehicles exiting to the outside of the curve have little opportunity to recover, and are likely to enter the canal.

- Upgrade signs and pavement markings; pave shoulders (included in recommendations for all major curves).

*Widening CR 835 to the outside would involve some fill in the canal. The recommended alternative is to widen the pavement to the inside of the curve, and shift the travel lanes further away from the canal.*

*This would require extension and possible replacement of one or more culverts on Blumberg Road. Hendry County has indicated they would replace this culvert.*

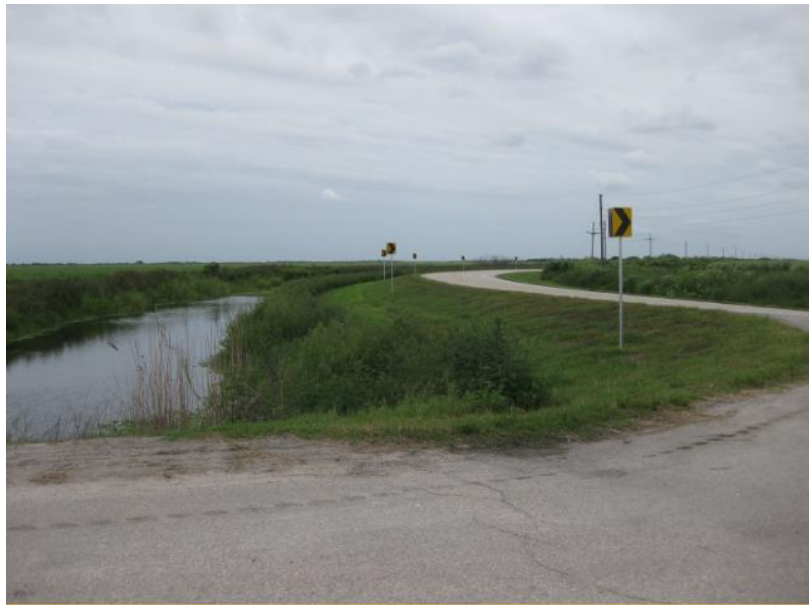
This photograph, looking southeasterly from Blumberg Road, shows the shoulder sloping downward toward the canal. A vehicle that leaves the road in this area would have difficulty staying out of the canal.

**Figure 19 Canal along outside of curve at Blumberg Road**

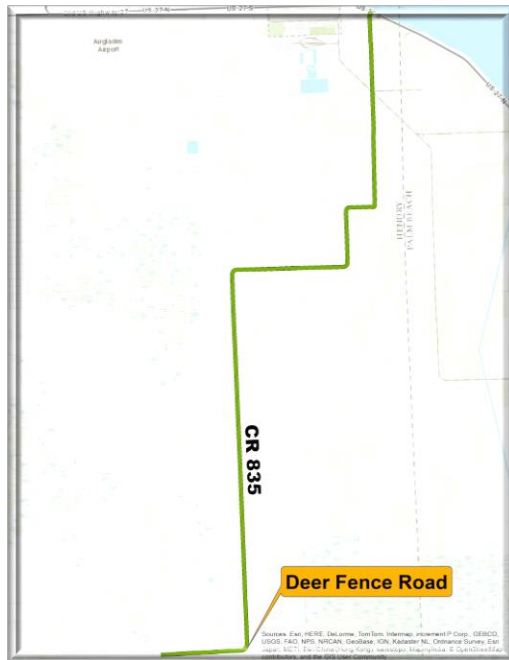
**Figure 21 CR 835 at Deer Fence Road**

CR 835 intersects an unpaved road, designated as Deer Fence Road, at a 90 degree curve. A SFWMD canal is located along the inside radius of the curve. There is a bridge over a canal at approximately the midpoint of the curve. The bridge has guardrail on the approaches, but this guardrail is short and leaves an unprotected area. Shoulders on both sides of the road are unpaved and show signs of erosion and pavement edge drop-offs. (See Figure 23)

During the study period, no crashes were reported within the limits of the curve; however, there were crashes to the north and west of the curve. The canal crossing with a narrow bridge, the intersection, and the change in alignment all add risk factors that make conditions at the curve even more severe.

- Upgrade signs and pavement markings; pave shoulders (included in recommendations for all major curves).
- Upgrade and extend guardrail at bridge.

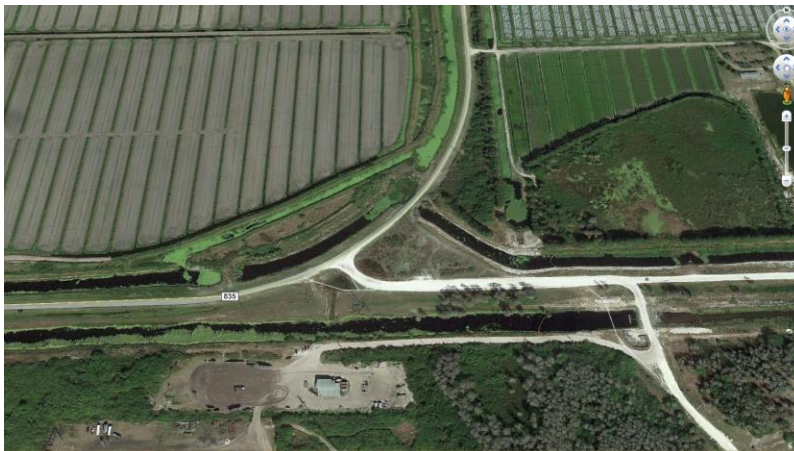
**Figure 22 Curve at intersection of Deer Fence Road with CR 835**

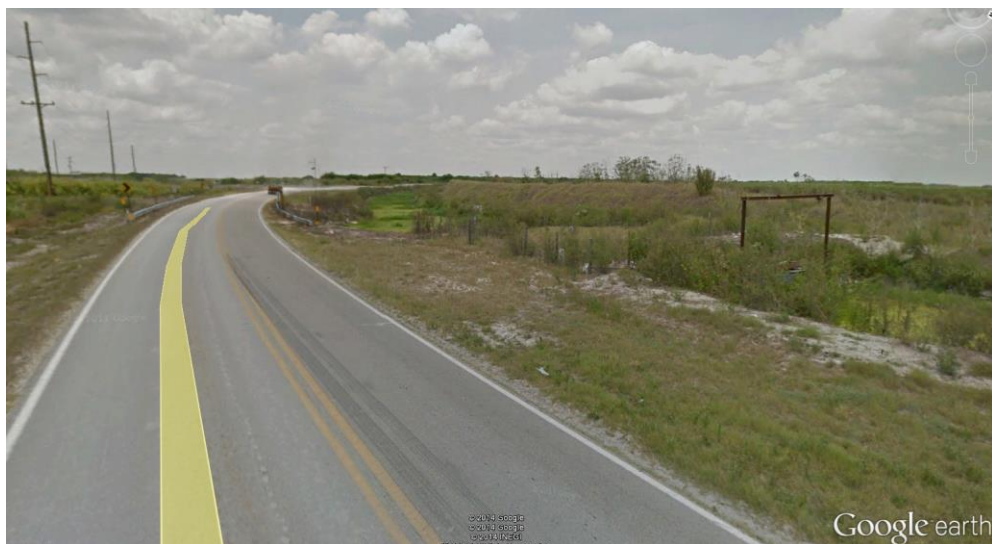
**Figure 23 Southbound approach to curve at Deer Fence Road**

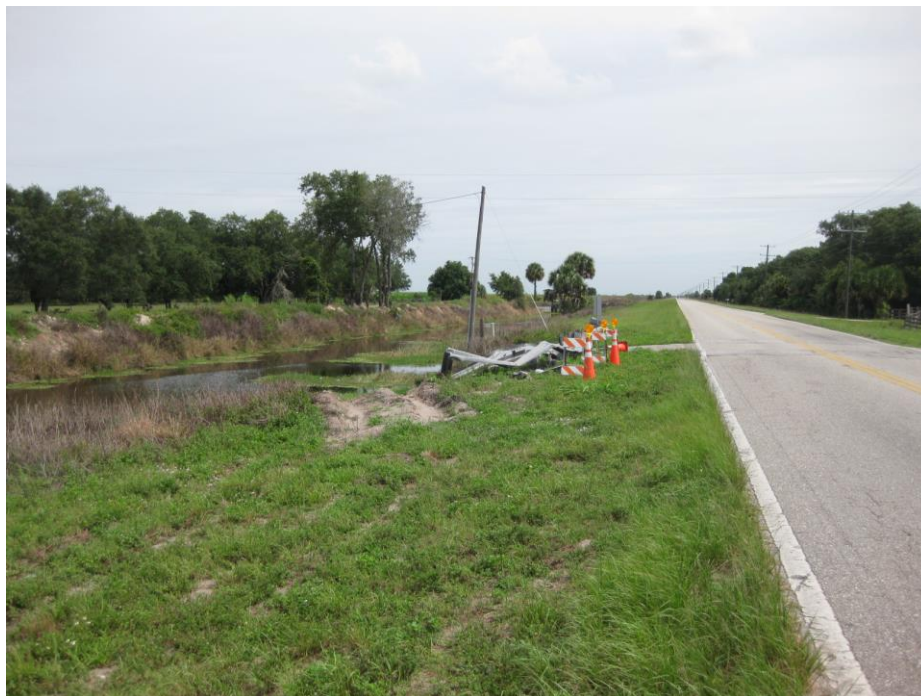
In this recent crash, the driver reportedly fell asleep and crossed the road, striking the end of the guardrail. The vehicle overturned into the canal. Driver and passenger were able to escape by breaking out a window and sustained only minor cuts from the broken glass.

Figure 26 Crash site where vehicle entered canal

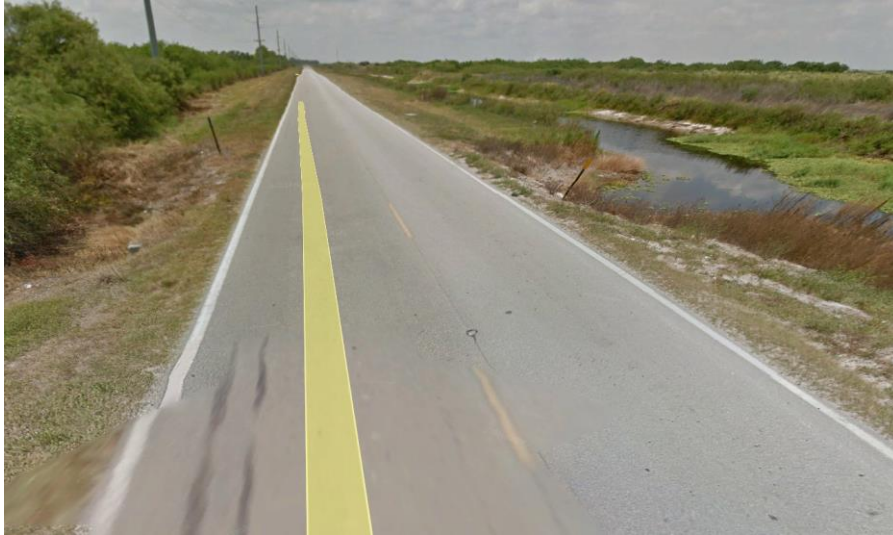
This photograph shows an unprotected crossing on CR 835. Pavement is approximately 20 feet wide. Distance between end walls is approximately 30 feet.

Figure 27 Canal crossing without guardrail on CR 835

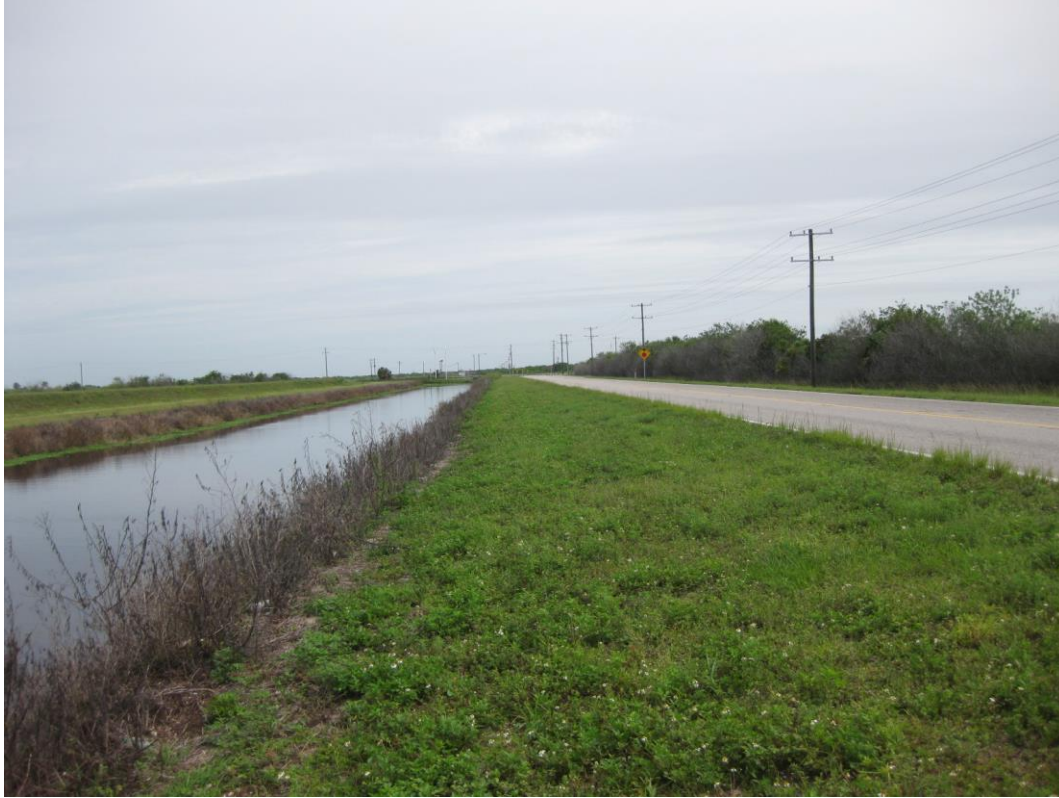
CR 833 from Java Avenue to SR 80 (4 miles) is bounded on the west side by a continuous canal under the jurisdiction of the South Florida Water Management District (SFWMD). The distance between the canal and the roadway varies from less than 20 feet near the intersection with SR 80 to more than 30 feet. Guardrail installations are present at intersections/driveways that cross the canal, but these generally extend only a short distance along CR 833.

**Figure 30 Canal along west boundary of CR 833 south of SR 80**

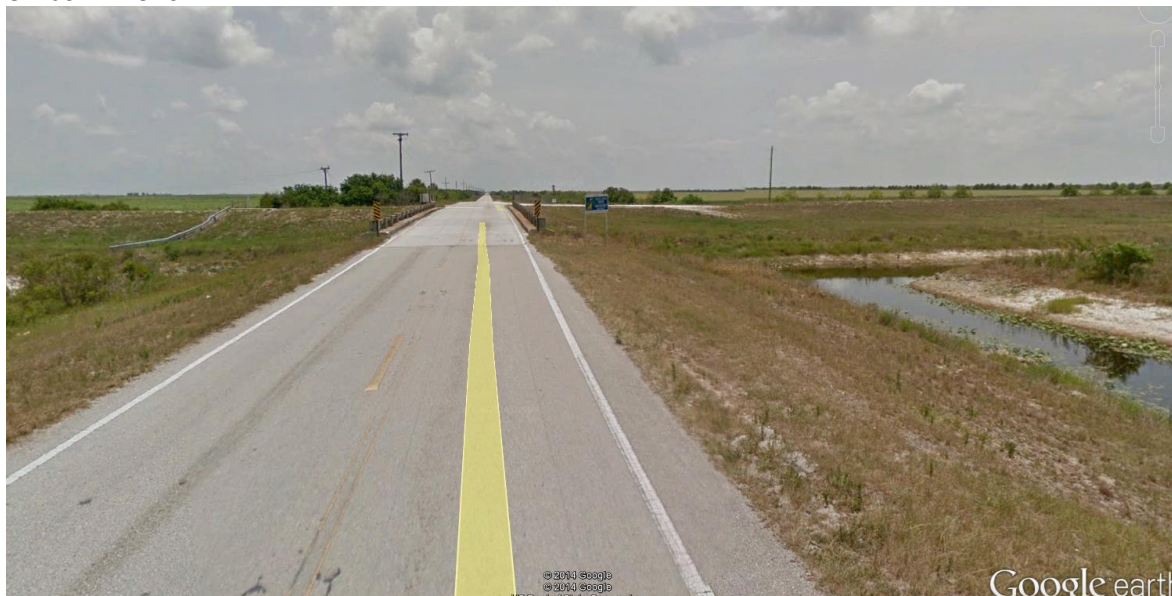
The bridge crossing the canal is narrow and does not have guardrail on the approaches. Traffic on CR 835 is exposed to both the canal crossing the road and canals on each side of the embankment.

**Figure 32 Eastbound approach to bridge over L-1 Canal**

- Advanced warning signs alerting drivers to the intersection and narrow bridge.
- Guardrail at the bridge (Figure 35). Guardrail should be extended across the bridge.

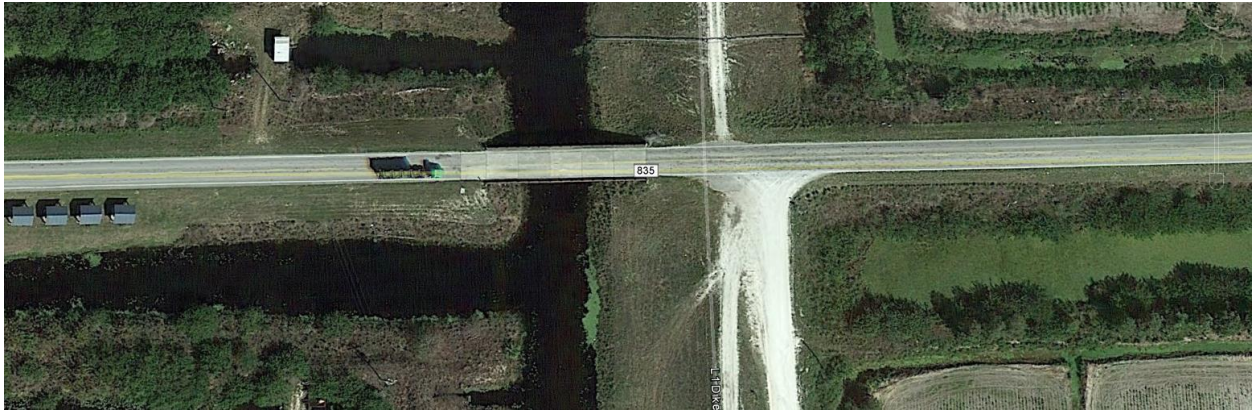
**Figure 33 Intersection of L1 Dike Road**

Although no crashes were reported at this intersection, the skid marks on the CR 835 approaches indicate that advanced warning for the intersection is needed. One reported crash was attributed to a vehicle with a wide load striking the bridge rail.

No crashes involving vehicles entering the canal at this specific location were reported during the analysis period; however, a recent crash was reported in which a vehicle entered the canal in the area of the boat ramp just west of the canal. The steep slopes on the approaches and the narrow bridge with exposed abutments are risk factors not present at most other locations in the corridor where vehicles did enter a canal.

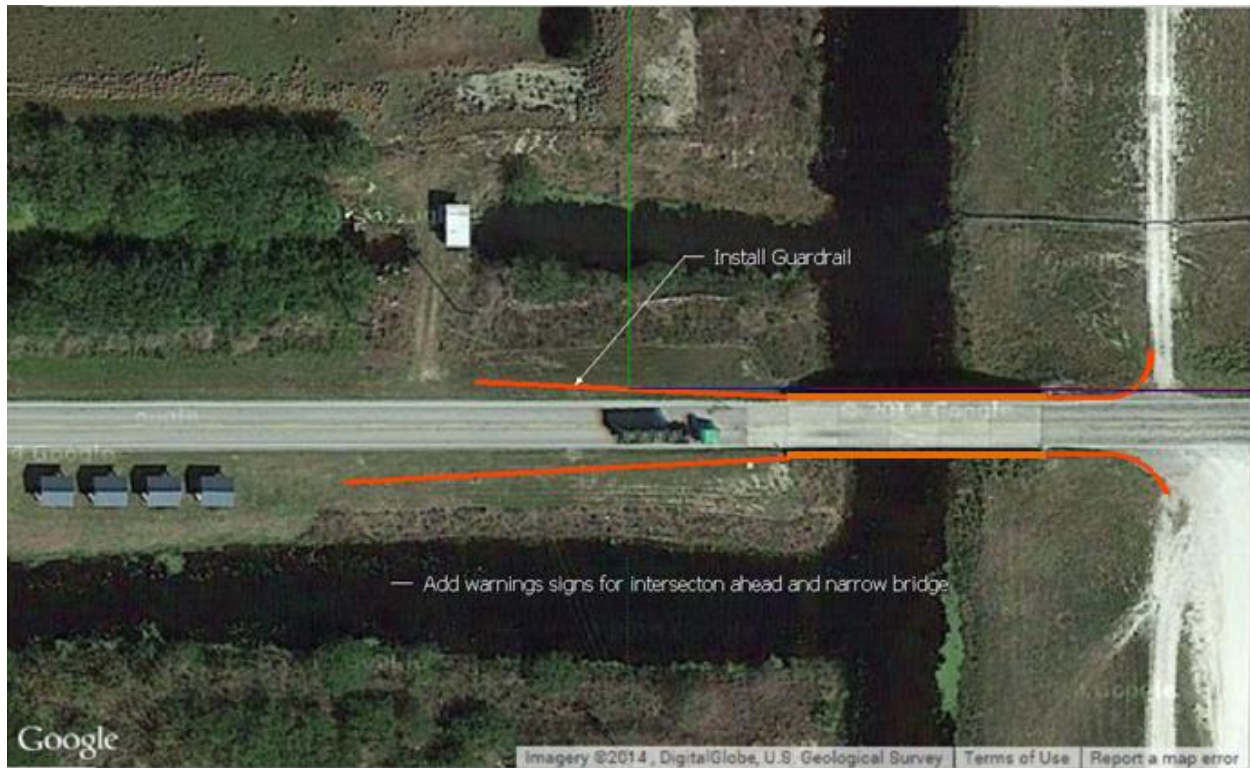
Figure 35 Recommended guardrail at L-1 Canal / Intersection

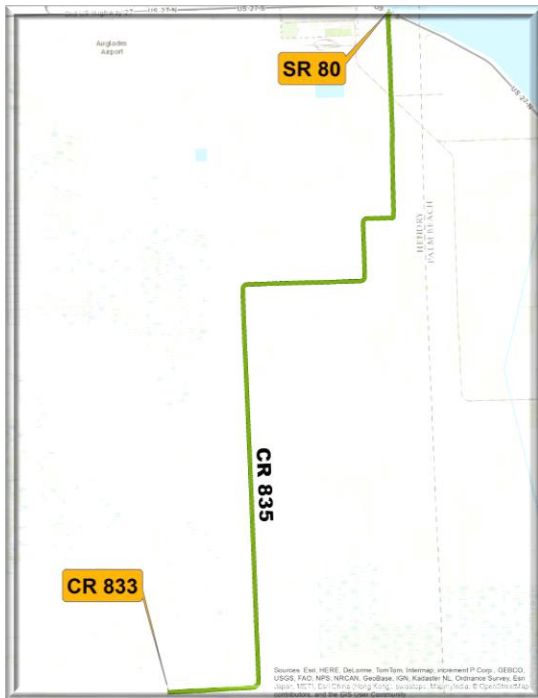
**Figure 36 CR 835**

The northern end of this corridor (approximately 1.5 miles) lies within the developed area of Clewiston. The rest of the corridor passes through a large agricultural area. Throughout much of the corridor, large canals are located along at least one side of the road.

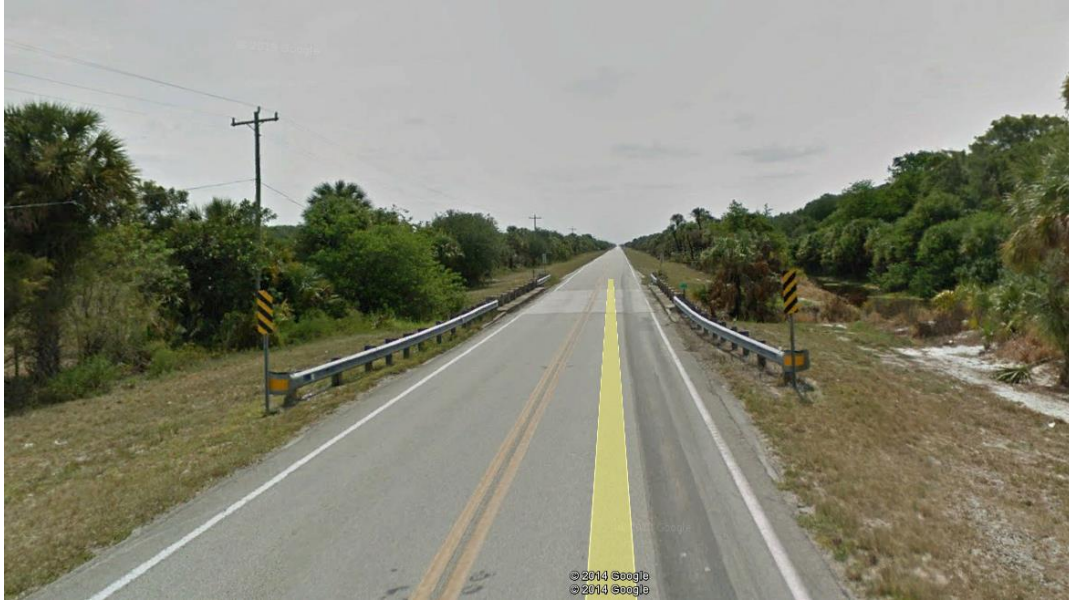
**Figure 40 Guardrail protection at major canal crossing**

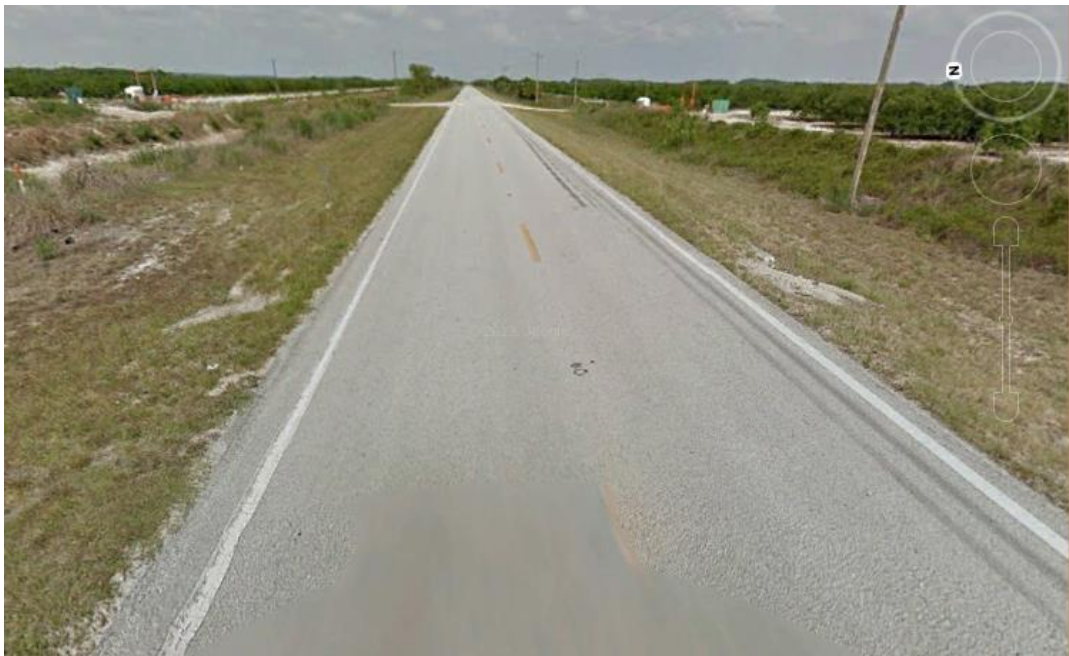
**Figure 41 “Unprotected” culvert crossing on CR 846**
