SITE ANALYSIS AND JUSTIFICATION

JACKSON COUNTY

TASK 3 AND 4 REPORT SUPPLEMENT-2

The Florida Department of Transportation

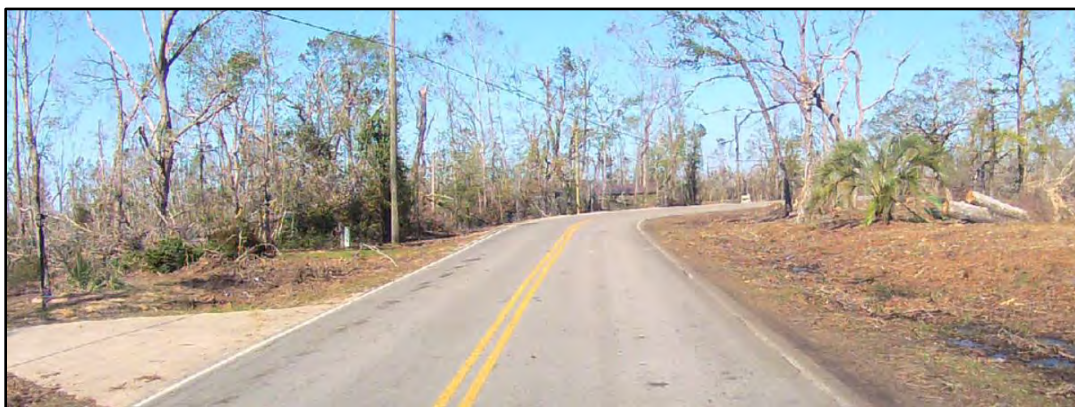
Figure 7. Indian Springs Rd curve, existing condition

Indian Springs Rd serves as access to the Indian Springs subdivision. The speed limit through this area is 25 mph with advisory speed of 15 mph on some curves, but reported speeds are higher. Figure 7 shows the condition of this segment on 12/5, 2018. Curve warning signs and pavement markings are limited.

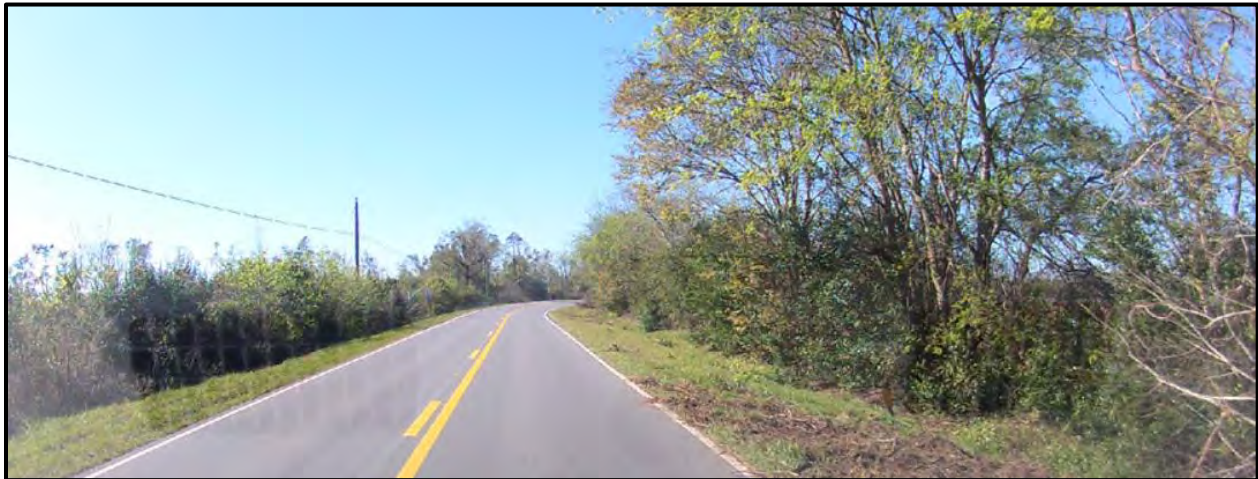
Figure 9. CR-280 from SR-73 to SR-71 (Curve 2-2, looking west)

Figure 9 shows the condition of CR-280 on 12/5, 2018. This road has center- and edge-line pavement markings and centerline RPMs.

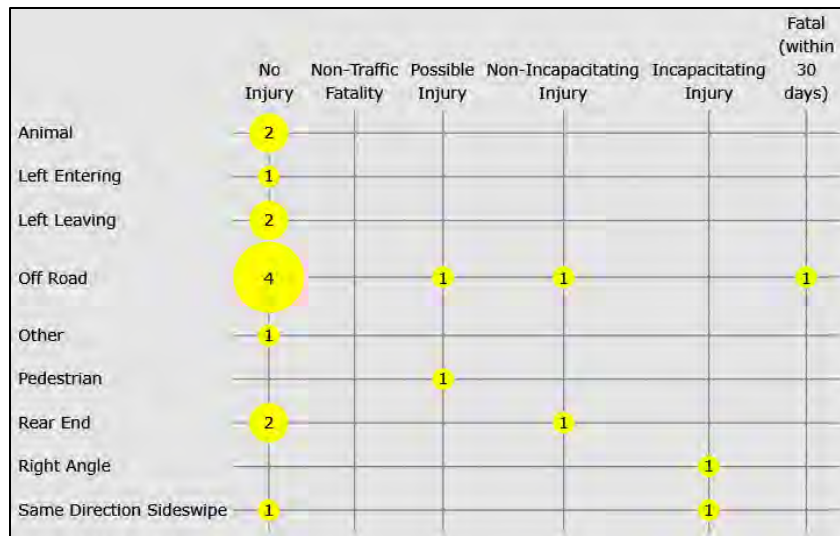
Figure 10. Crash type vs. severity on CR-280 from SR-73 to SR-71

Figure 10 shows that this segment experienced one fatal crash, six injury crashes, and 13 PDO crashes. Four injury crashes and five PDO crashes were due to lane departures. Crashes on this segment were concentrated in the two curves and at the intersection with Bear Paw Lane, as shown in Figure 8 and Table 3. There were two PDO crashes and one injury lane departure crash on Curve 2-1, and the injury occurred in non-daylight condition. Curve 2-2 experienced two PDO crashes, one injury crash, and one fatal crash. All four were lane departure crashes. The two crashes involving injury and fatality both occurred during non-daylight hours.

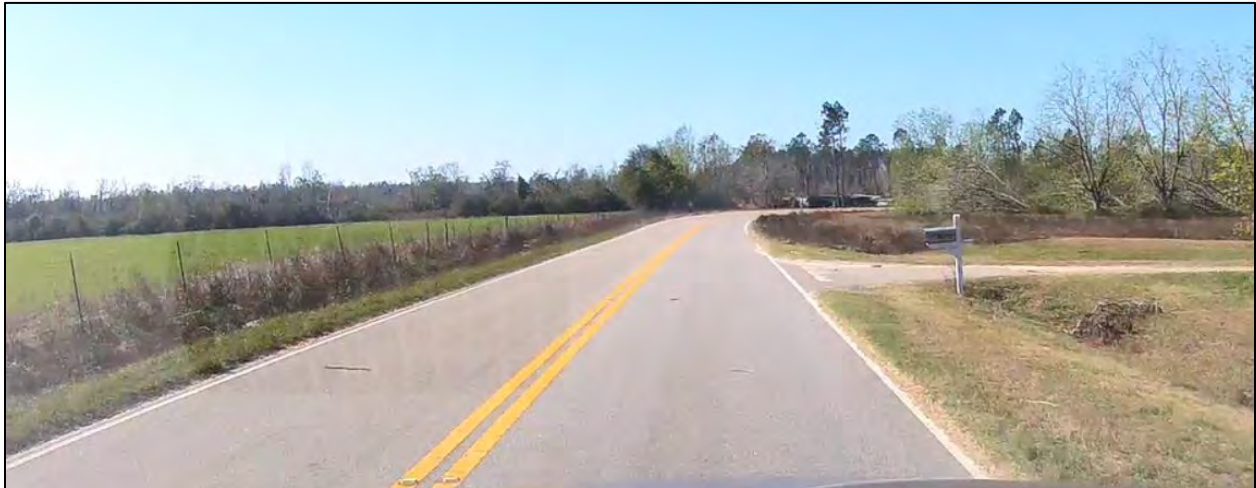
Figure 14. Existing condition of CR-1656 (on 12/5, 2018).

This road has center- and edge-line pavement marking, and centerline RPMs as shown in Figure 14

Note: Pavement condition at the time of the field review showed some distress and had been crack sealed. Pavement condition should be reevaluated before installing pavement markings.

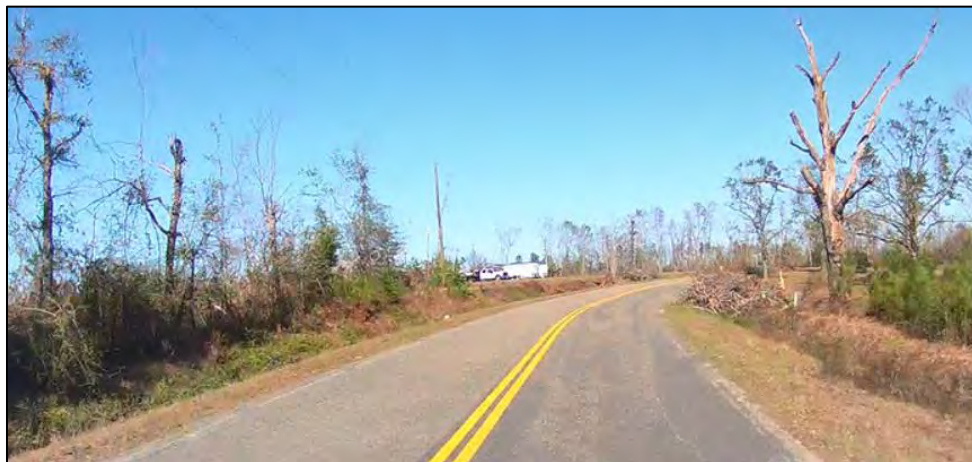
Figure 16. Existing condition of Holley Timber Road from US-231 to CR-276 (12/ 5, 2018)

Figure 16 shows the existing condition of this segment. The edge-line pavement markings were barely visible.

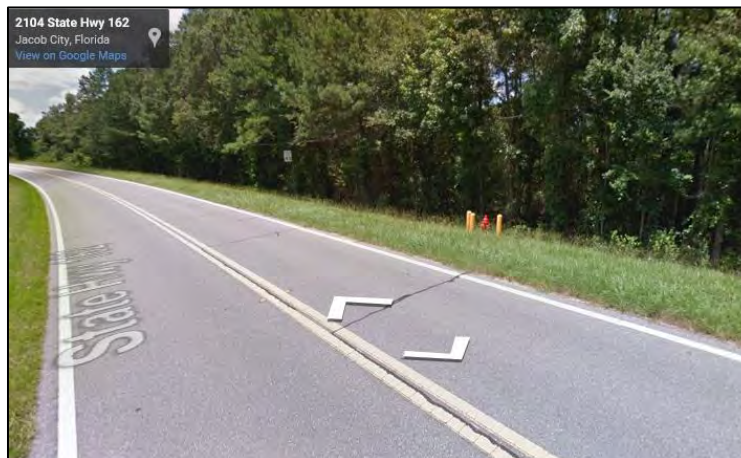
Figure 18. Hydrant and bollards on outside of curve in Jacob City (on Curve 6-2)

In the Jacob City area, fire hydrants have been installed within the right of way. Bollards have been placed around the hydrants in Curve 6-2, presumably to protect them from errant vehicles. These hydrants and bollards pose a risk to vehicles that leave the roadway and can be especially problematic when they are located on the outside shoulder of a curve, as shown in Figure 18.

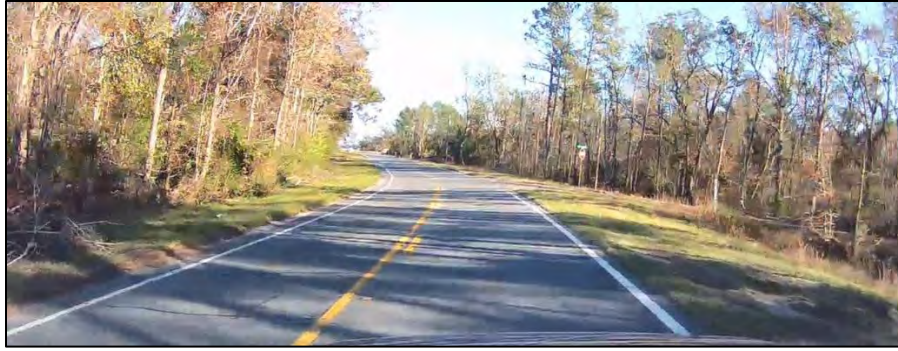
Figure 19. Existing condition of CR-162 from SR-273 to Chipola River

This road has center- and edge-line pavement marking, along with centerline RPMs as shown in Figure 19. The curve signage on this road is limited.

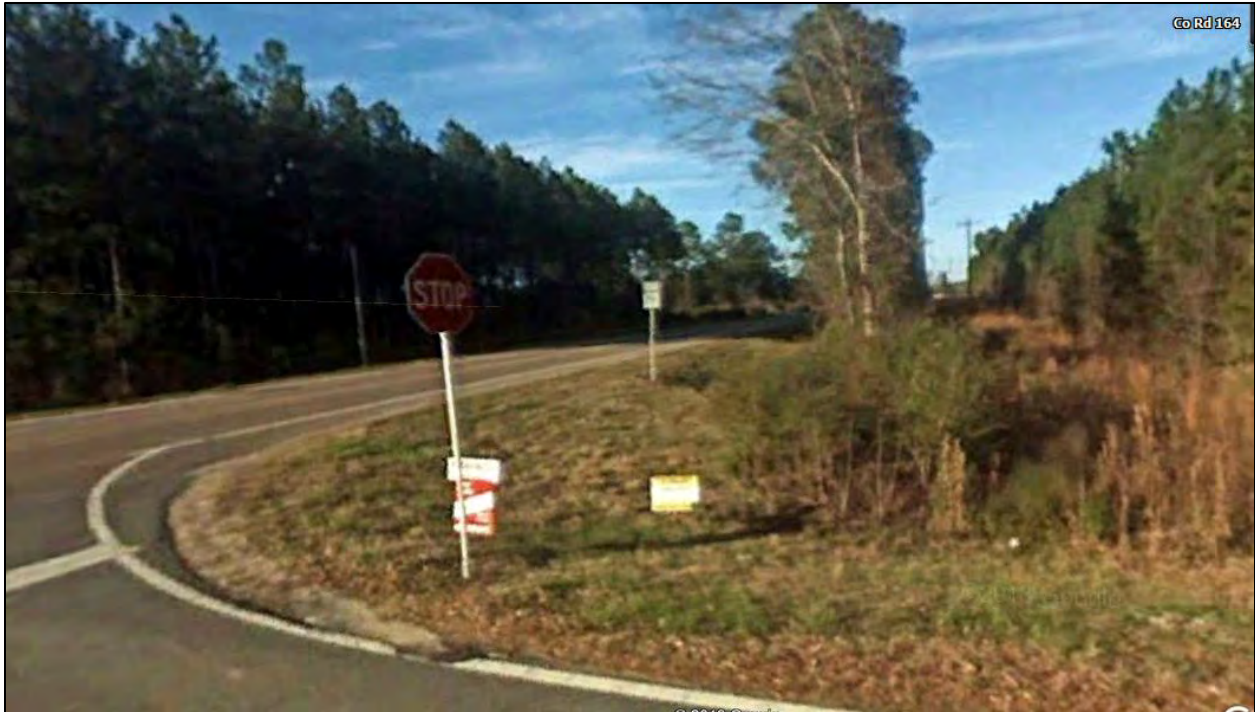
This is a two-way stop-controlled intersection, with-CR 164 as the minor approach. As shown in Figure 22 and Figure 23, trees along SR-77 in the NE of the intersection restrict visibility for westbound (WB) vehicles approaching the intersection.

Figure 22. Trees along SR-77 at CR-164

Figure 23. Visual obstruction at intersection of CR-164 and SR-77

It is recommended that FDOT review this condition and remove any trees in the SR-77 right of way that 5/be obstructing visibility.

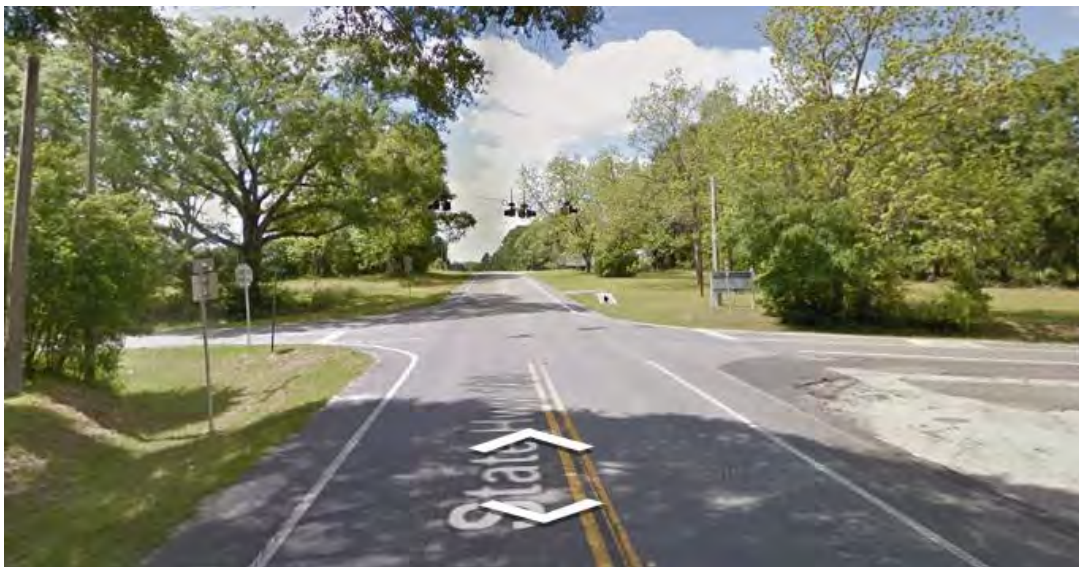
Figure 24. Visual obstruction due to hill at intersection of CR-164 and SR-273

This is a two-way stop-controlled intersection, with CR-164 as the minor approach. There is a visual obstruction at this intersection due to a hill on SR-273 south of the intersection, as shown in Figure 24. It is suggested that FDOT consider installing an Intersection Conflict Warning System (ICWS).

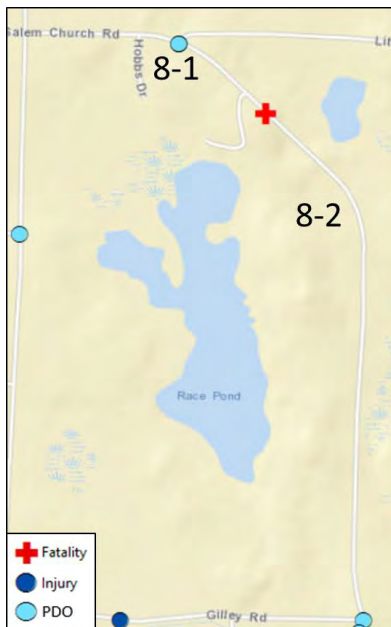
Figure 25. Salem Church Rd

Salem Church Rd connects Sandridge Church Rd with Howell Rd through an area of mixed land use, primarily agricultural with scattered residential properties along the road. Salem Church Rd has been recently reconstructed with standard lanes, pavement markings, and warning signs. There are two curves with radii of less than 1,500 ft at the north end of the road. None of the curves are marked with chevrons.

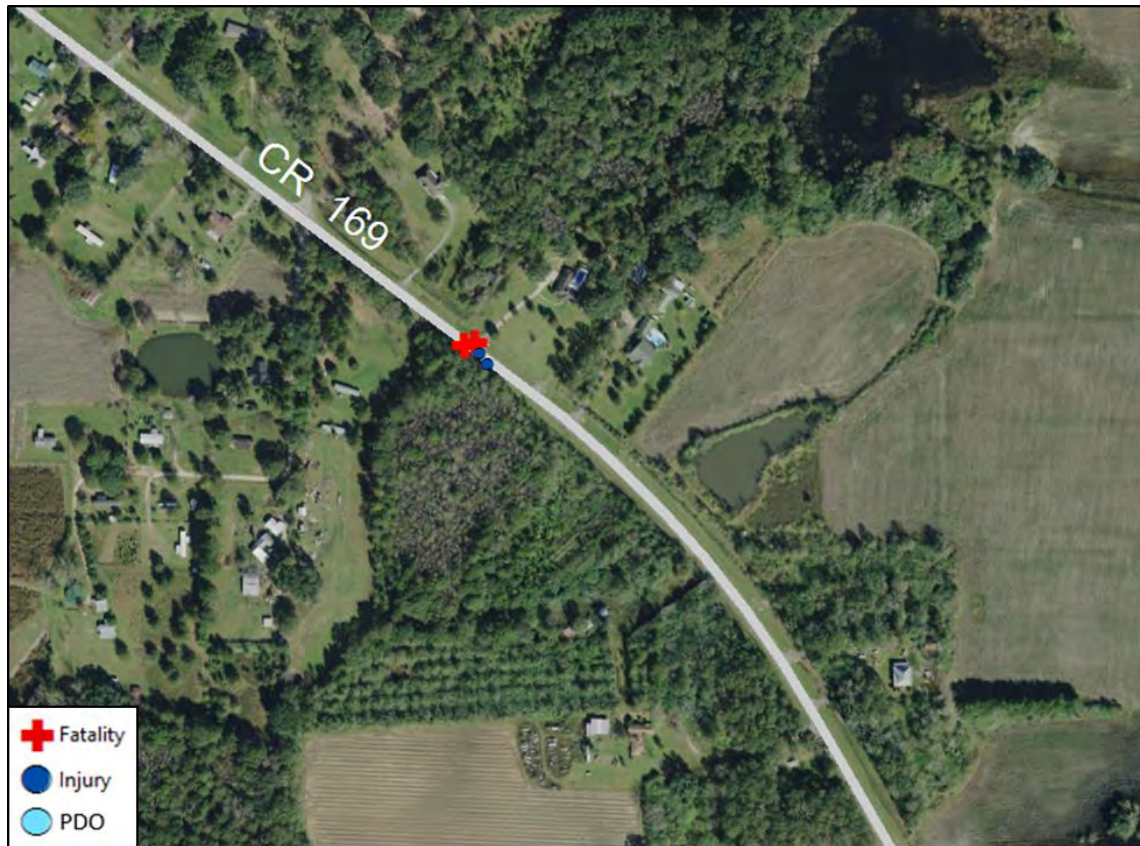
Figure 32. CR-169 adjacent to Treetop Rd

This curve is located south of Treetop Rd as shown in Figure 32. There are multiple culverts on the east side of the curve. These culverts increase the risk to the vehicles leaving the road.

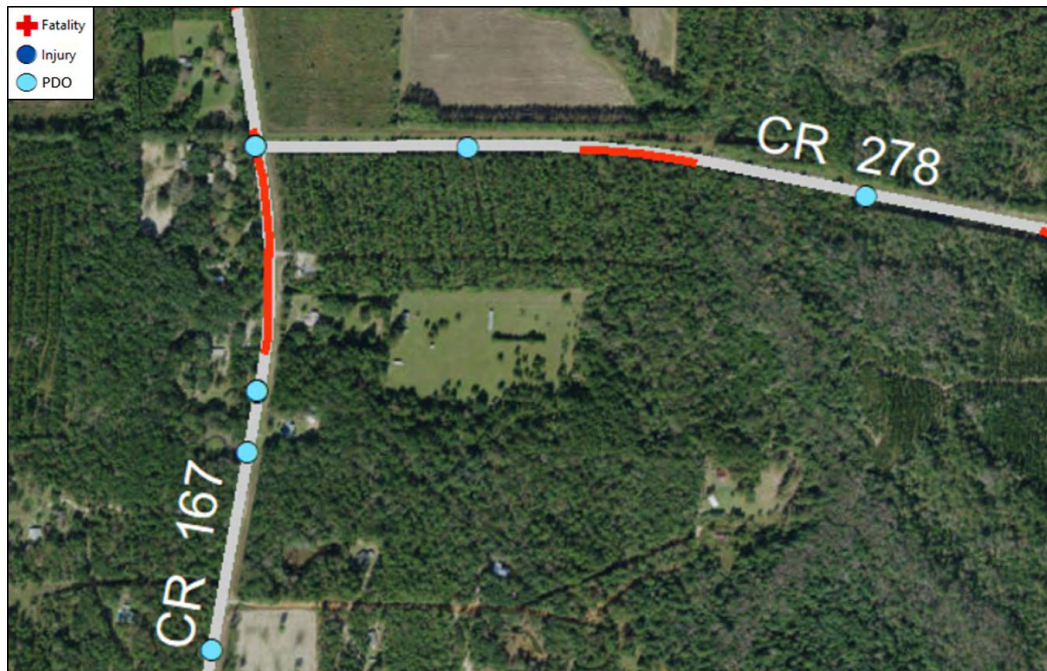
Figure 33. CR-278 at CR-167

This site is a T-intersection between CR-167 and CR-278, controlled by a stop sign on CR-278. The surrounding area is largely forested, with scattered residential development along CR-167 as shown in Figure 33. Both roads are two lanes with no turning lanes at the intersection. Posted speed limits on both CR-278 and CR-167 are 55 mph.

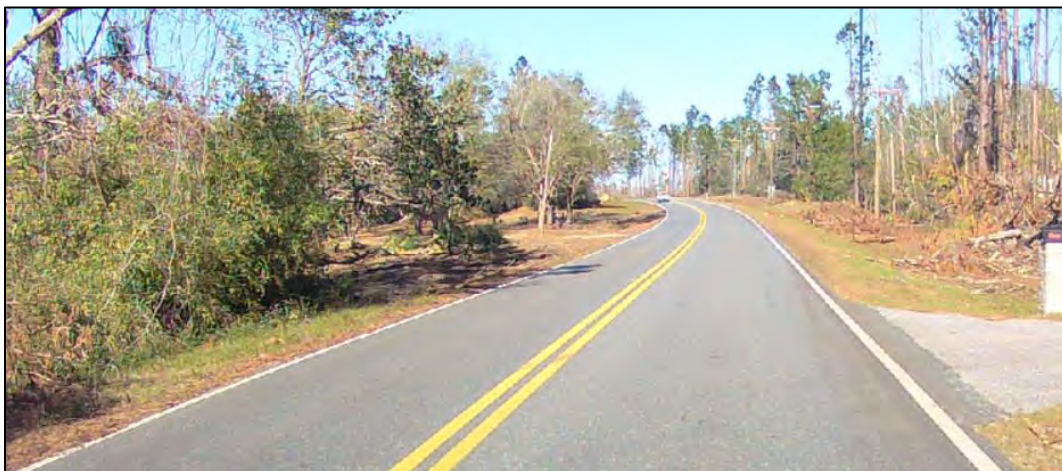
Figure 34. Restricted sight distance between vehicles approaching from S and E

The south leg of the intersection includes both a horizontal and vertical curve. This limits the distance at which vehicles approaching from the S and E can see each other and shortens the time available for either driver to react to approaching traffic, as shown in Figure 34.

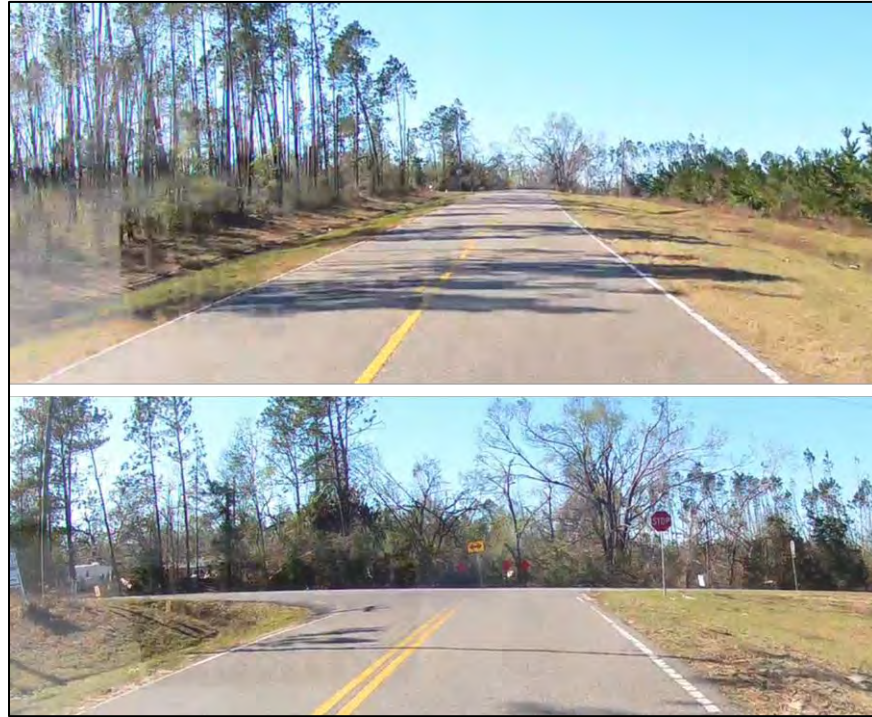
Figure 35. CR-278 approach to CR-167 intersection (top); intersection of CR-278 and CR-167 (bottom)

The CR-278 approach is on an uphill grade with the crest of the hill at a short distance from the intersection. The CR-278 approach is marked with a double arrow and object markers, and there are rumble strips on the WB lane, but the view of the pavement at the intersection is hidden by the crest of the hill as shown in Figure 35.
