SITE ANALYSIS AND JUSTIFICATION

COLUMBIA COUNTY

TASK 3 AND 4 REPORT SUPPLEMENT-1

The Florida Department of Transportation FDOT Contract BDV32-945-001

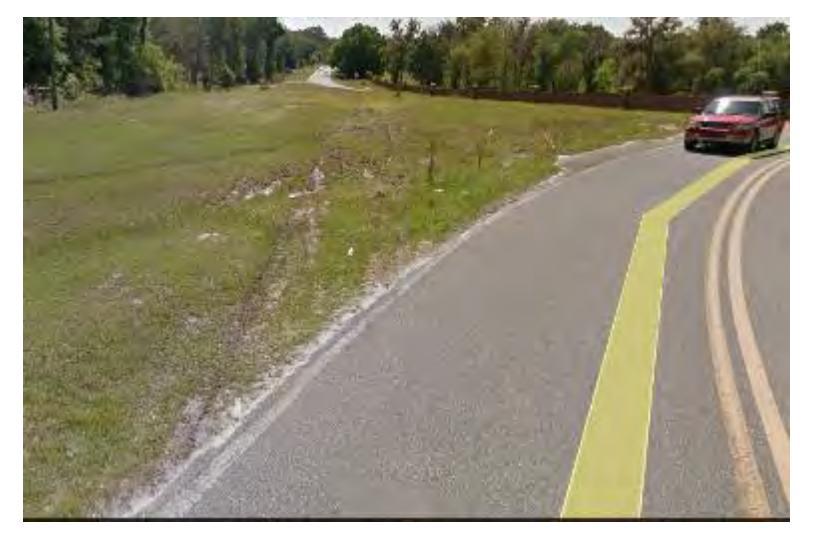
Figure 15. Evidence of lane departures at the curve on Deputy J Davis Ln

The absence of the visual cue to slow down for the curve appears to have contributed to lane departure crashes at this location. Chevrons have been doubled (two regular chevrons on each pole).

The friction demand for WB vehicles approaching the intersection is exaggerated by at least three factors: downhill grade on the approach, the curve, and the short distance a driver who fails to acknowledge the advanced warning signs has to apply brakes. On December 13, 2018, a high-friction surface treatment was implemented.

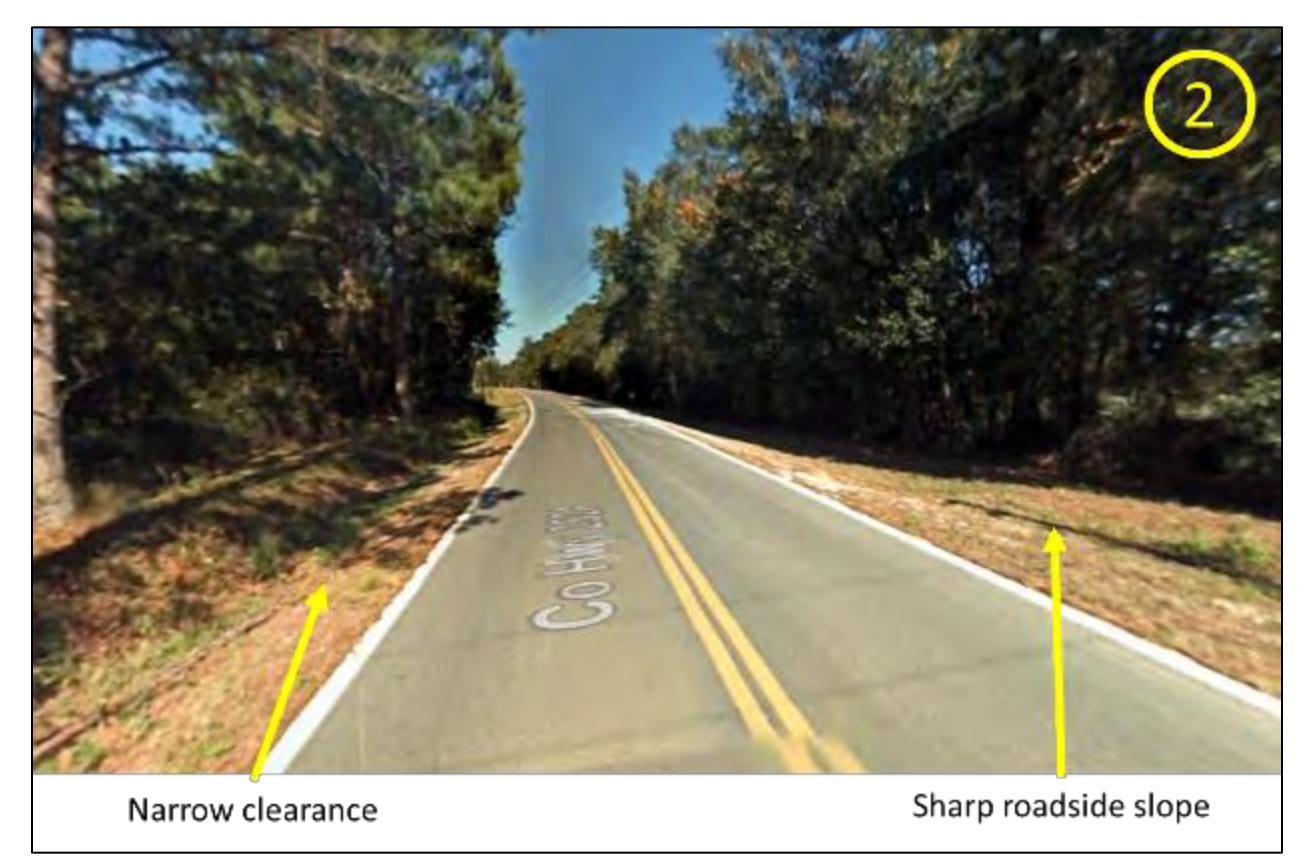
Figure 21. CR-252A curve #2, looking north
Emphasis Areas for Countermeasures

There were four nighttime curve-related crashes (one fatal, two injury, and one PDO). Field observation noted that there was no "Curve Ahead," chevron, or RPM for this curve. In addition. There is no paved shoulder for recovery, and one side of the curve has narrow clearance and sharp roadside slope (Figure 20 and Figure 21). Curve #1 has a small radius, with only 800 ft, and four of the crashes occurred on this curve. This curve is an ideal candidate for implementation of high-friction surface treatment (HFST) and internally illuminated RPM (IIRPM) because these measures can help the drivers decrease their speed effectively and negotiate the curve safely. All the crashes at curve #1 occurred SB with its downgrade curvature.

Field observation also noted that there were two chevrons on the wrong side of the road on curve #1, which we recommend be removed.

- Increase communication with the driver about the presence of the curve.
- Increase skid resistance on curve #1.
- Assist drivers in recognizing that the CR-252 intersection is two-way stop-controlled.

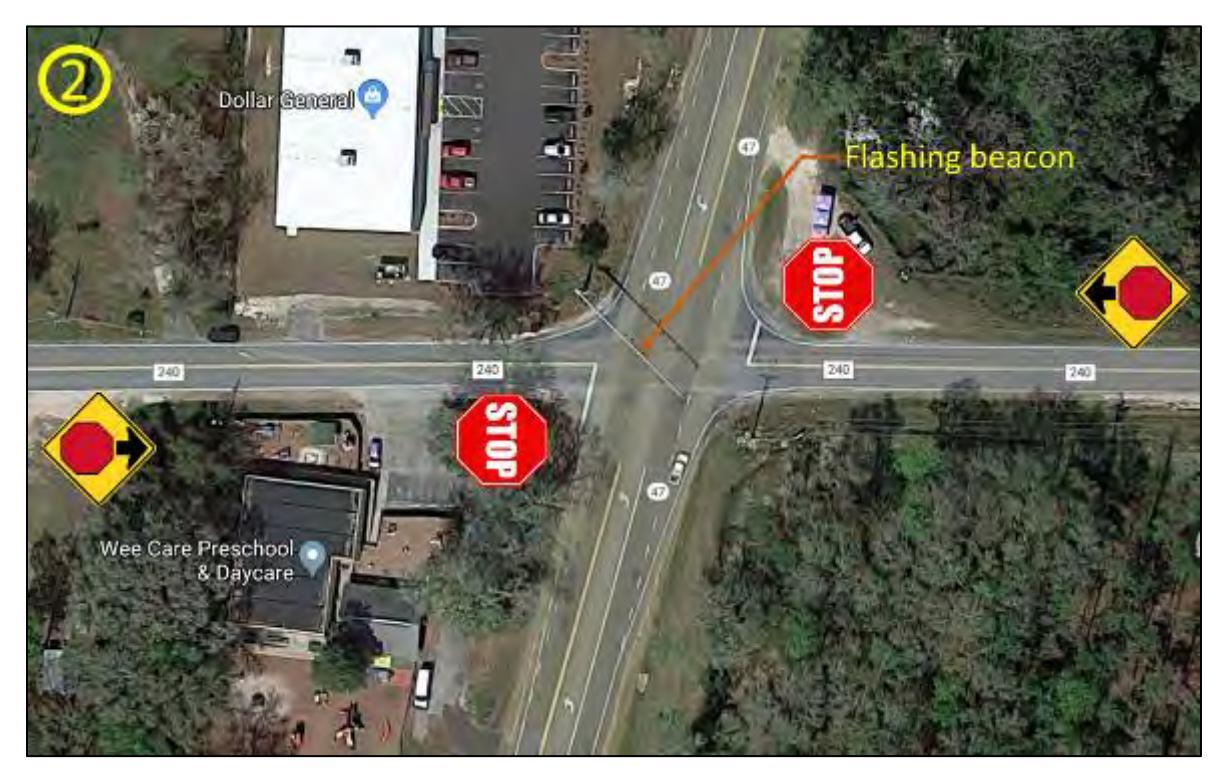
Figure 40. Existing condition of CR-240 site #2

Field Observations

Standard thermoplastic markings on center and edge line on both roads

Centerline RPMs on both roads

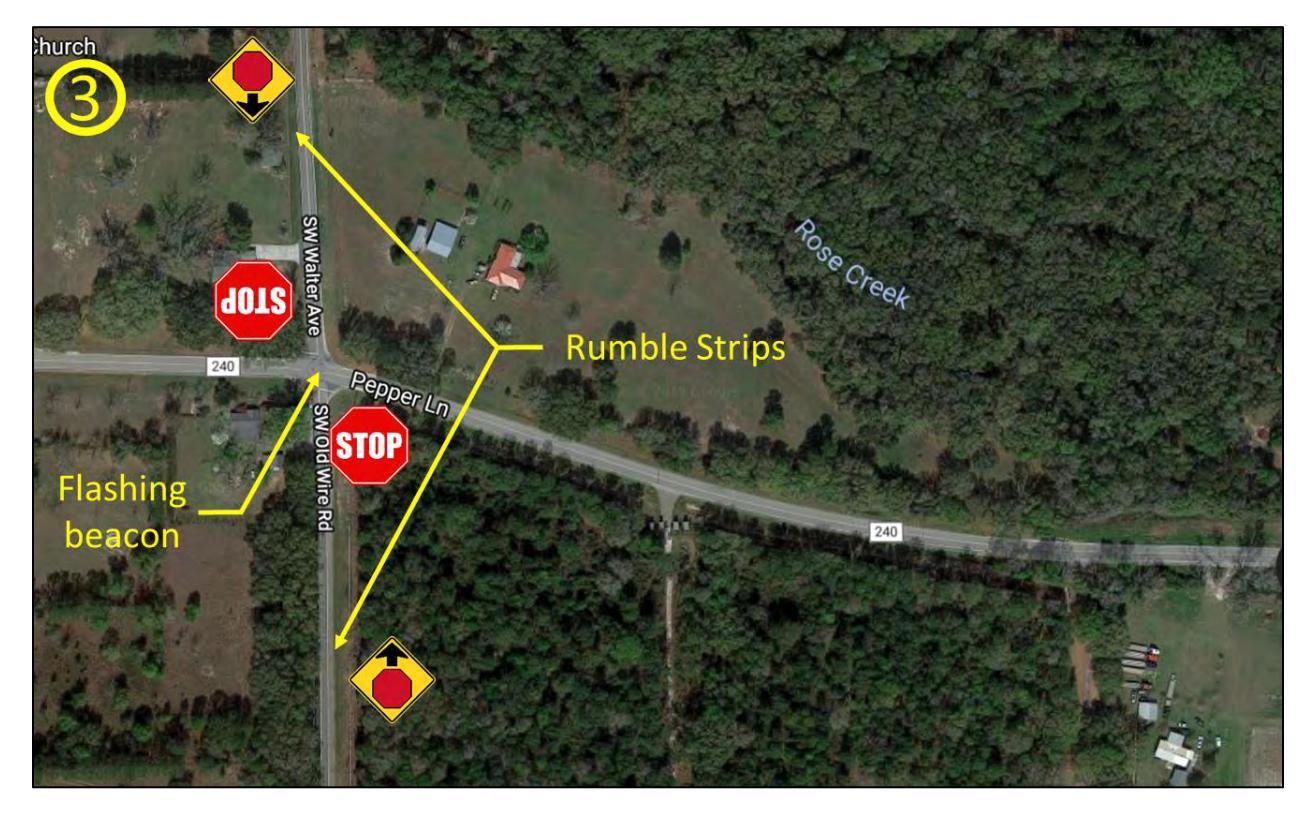
Figure 43. Existing condition of CR-240 site #3

The existing condition of this two-way stop-controlled intersection is shown in Figure 43.

- Signage:
 - Regular-size stop signs on SW Walter Ave and Old Wire Rd
 - Stop-ahead signs on Walter Ave
 - Flashing beacon at intersection
- Pavement markings:
 - Standard thermoplastic markings on center- and edge-line on both roads
 - Centerline RPMs on both roads

Transverse rumble strips on NB and SB approaches

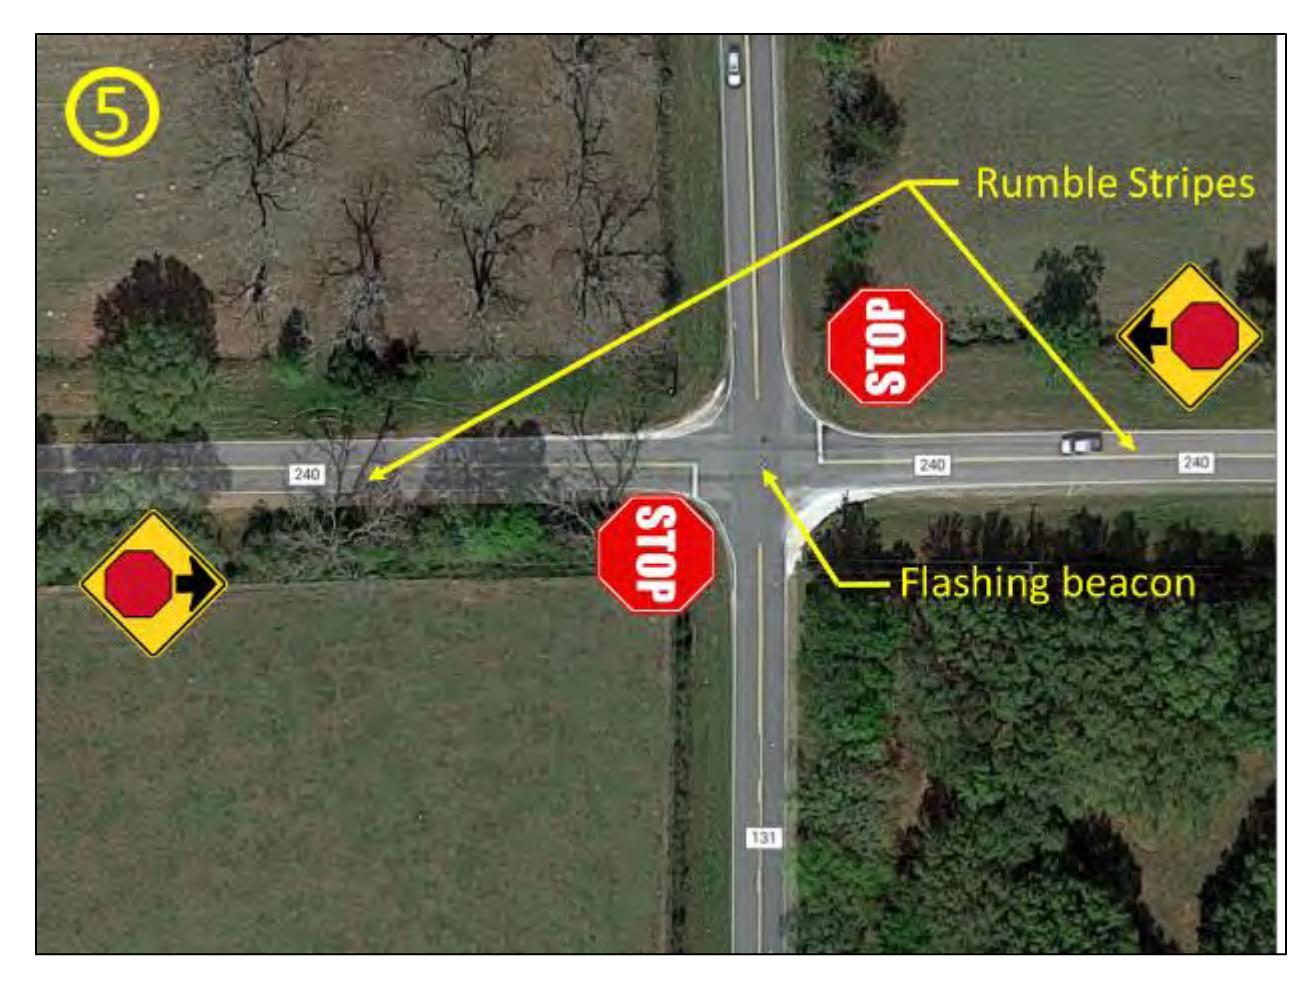
Figure 48. Existing condition of CR-240 site #5

The existing condition of this two-way stop-controlled intersection is shown in Figure 48. EB and WB have stop signs.

Centerline RPMs on CR-240, but no RPM on CR-131

Transverse rumble strips on intersection's EB and WB approaches

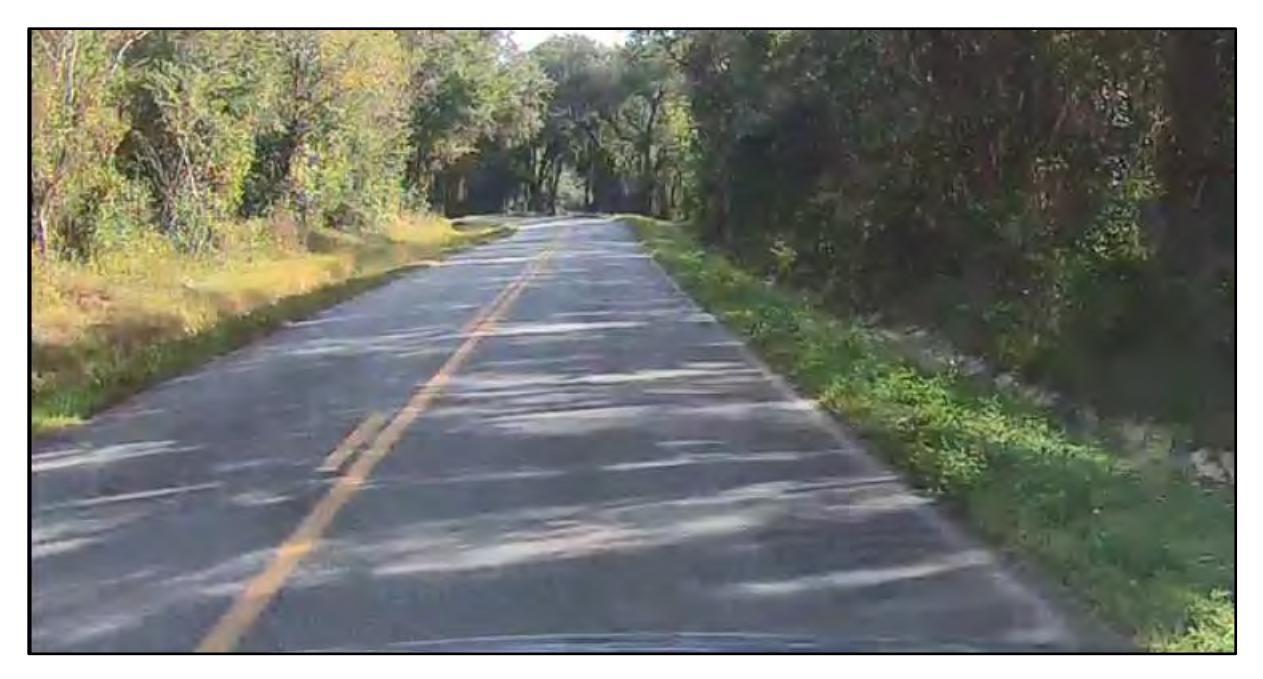
Figure 55. Existing condition of curve #1 on CR-349 from CR-131 to CR-245

Standard thermoplastic markings on centerline. The edge-line pavement markings have deteriorated and are barely visible

No RPMs

- Clear zone encroachments:
 - The clear zone is limited.

The road has no RPM, and the edge pavement markings are worn out.

- HFST
 - On outer lane of curves #1: As the vehicles negotiate the first curve (in each direction) successfully, most probably they can negotiate the second curve too.
- Signage
 - Large chevrons on the curves #1, and regular-size chevrons on curves #2
 - Curve warning signs on both set of curves
- Pavement markings:
 - Center- and edge-line RPM on curves

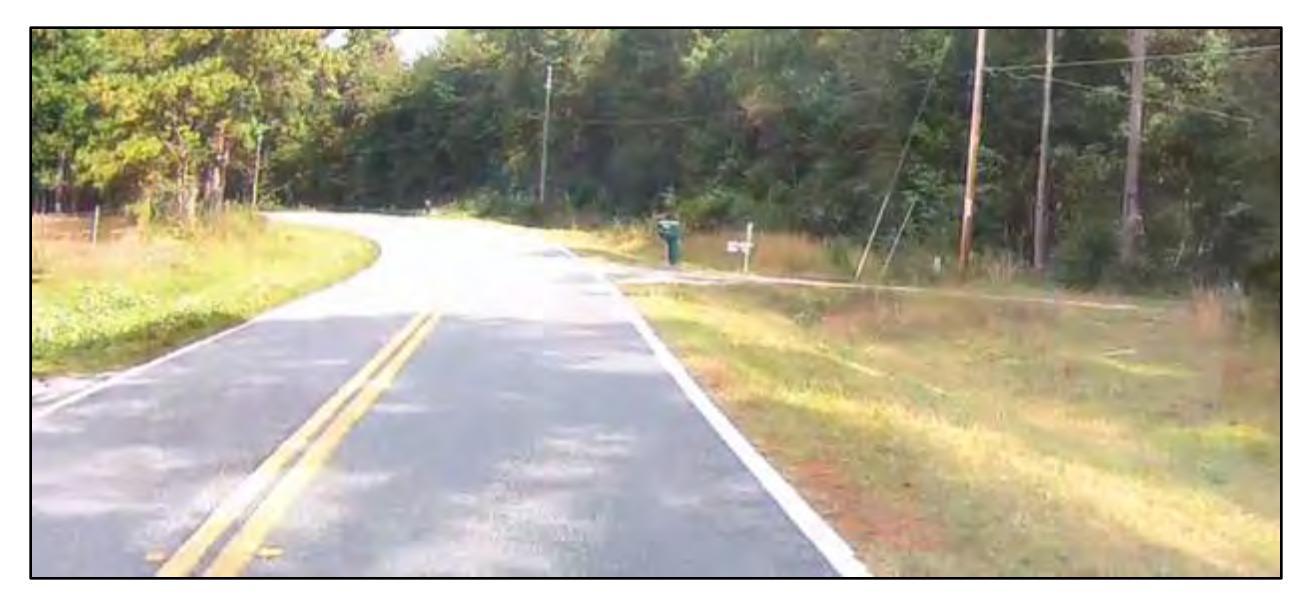
Figure 59. Existing condition of curve #1 on SE Country Club Rd (CR-133C) From Alfred St to SE Hillcrest Ln

Three crashes on the curves were nighttime crashes. It shows drivers have higher risk negotiating the curve in dark condition. Adding chevrons with bright sticks, and IIRPMs can help drivers to better be aware of the curve.

Two out of four crashes occurred on wet road surface condition. This suggests improving side friction on these curves. The curves radii are less than 1000 ft. HFST may help the drivers to negotiate the curves effectively.

- HFST on set of curves #1 on both lanes
- Chevrons (some curve warning signs are deteriorated. For such signs replacement is suggested)
- Center and edge line IIRPM on curves
- Advisory speed sign on NB after Alfred St

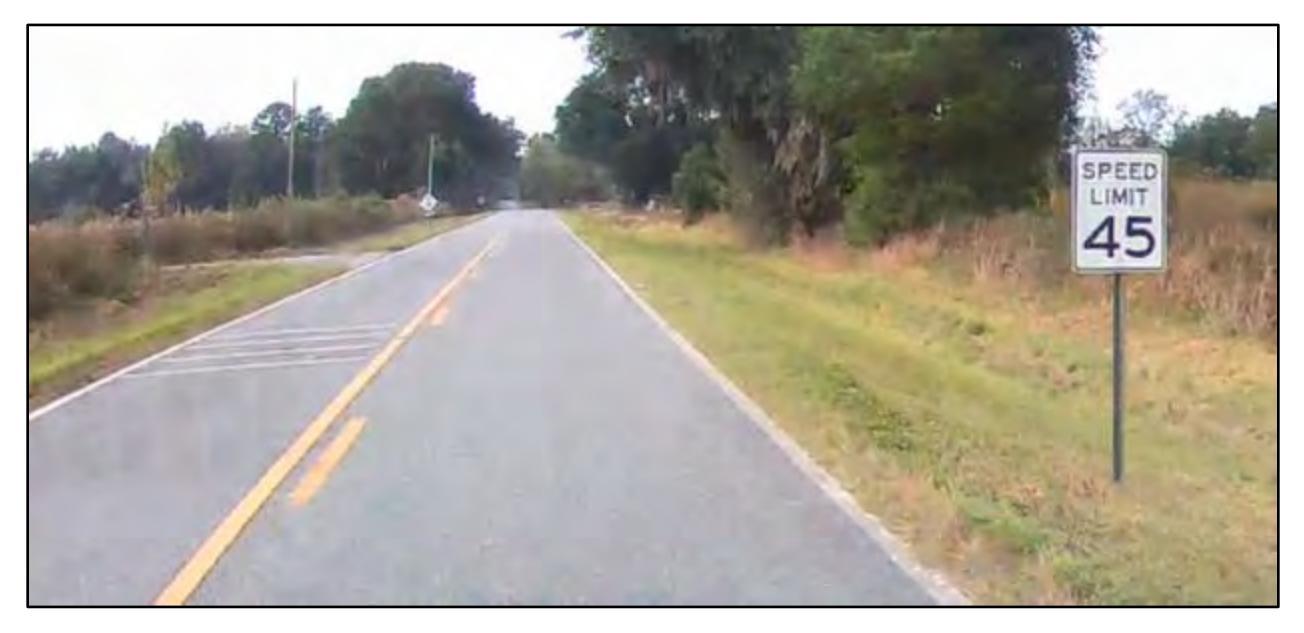
Figure 64. Existing condition of CR-246 from US-41 to US-441

Standard thermoplastic markings on center- and edge- line. Edge pavement marking are faded in some segments.

No RPMs

On US-41 intersection, there was a failed-to-stop injury crash. The intersection presence should be delineated more.

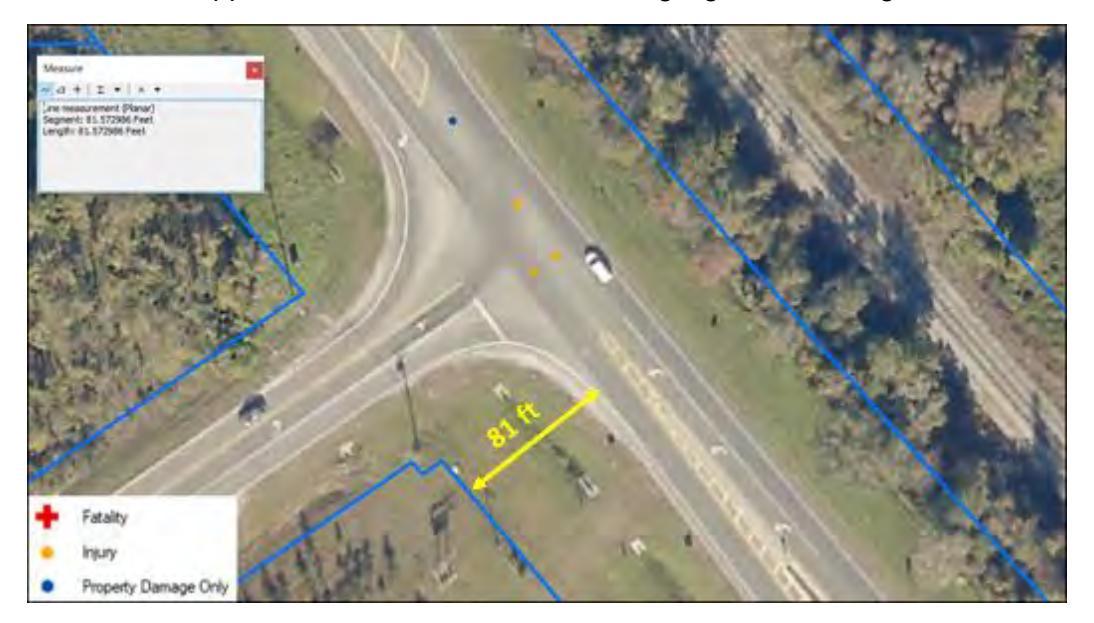
Figure 66. US 41 and NW Bascom Norris Dr

NW Bascom Norris Dr is the minor approach of this T-intersection, as shown in Figure 66. NW Bascom Norris Dr is a two-lane highway with a left-turn lane in approach to the intersection. US-41 geometry changes along its length. At the intersection, US-41 is a two-lane highway, with exclusive left-turn lane on NB and exclusive right-turn lane on SB. By going 0.2 miles toward SE, US-41 has two through lanes in each direction for almost 4.5 miles. On the north of the intersection, US-41 is a two-lane highway with intermittent turn lanes. All these changes in geometry can complicate the intersection situation for the drivers.

The left- and right-turning traffic on EB of Bascom Norris Dr block each other's sight distance. A right-turn acceleration lane would reduce the conflicting risk. The lines in Figure 66 show the property boundaries, which needs further analysis for available right-of-way estimation.

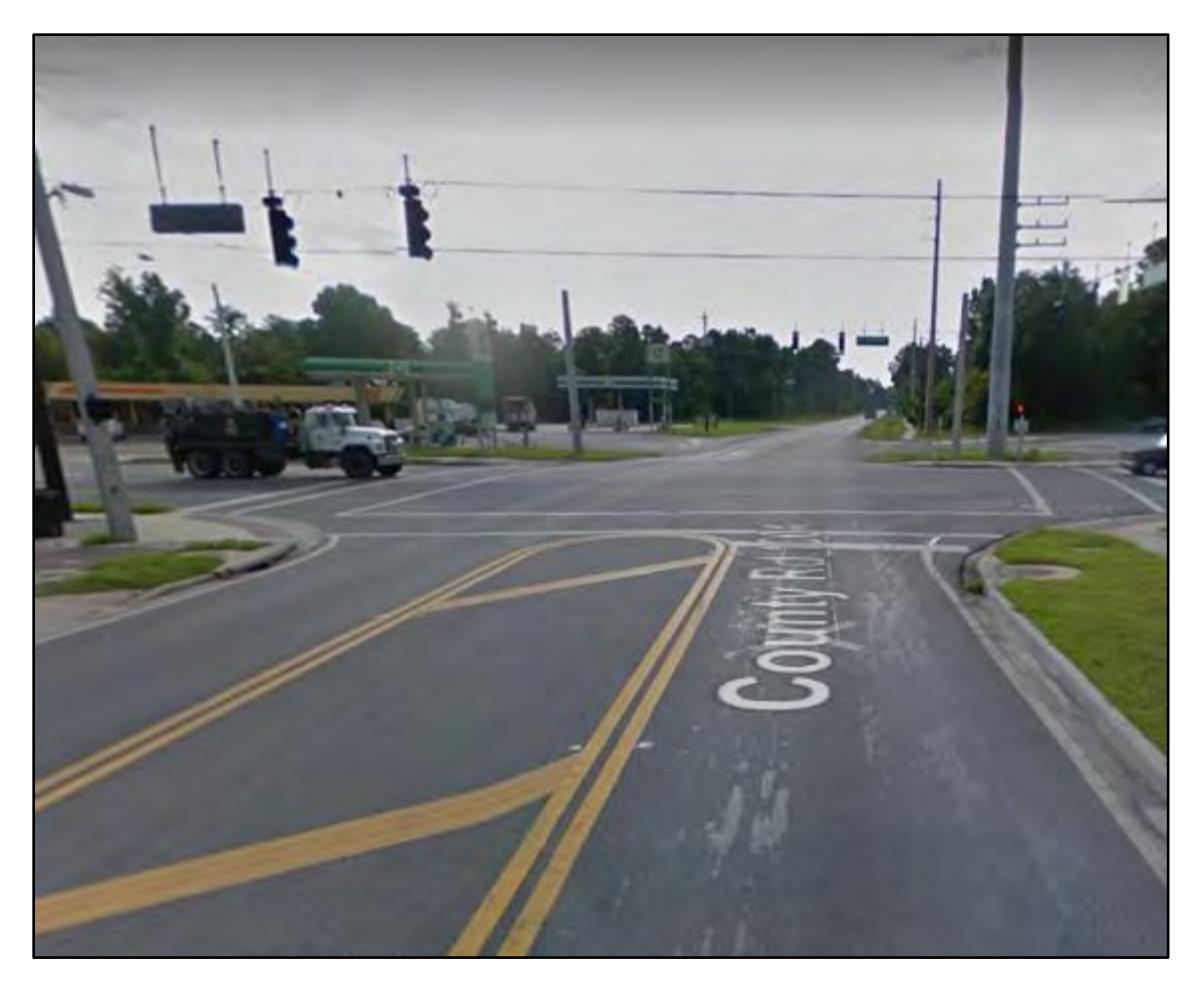
Figure 69. NW Bascom Norris Dr intersection EB approach

As shown in Figure 69, pavement in the west leg of the intersection appears to be wide enough to accommodate a left turn, but the space between the EB and WB lanes is marked out with cross hatching.

At this intersection, 35% of crashes were directly related to EB left-turn movement; however, it does not meet the requirements for recommending a protected left-turn phase. The crash risk could be reduced by adding a left-turn lane. Further review and analysis by FDOT will be required.

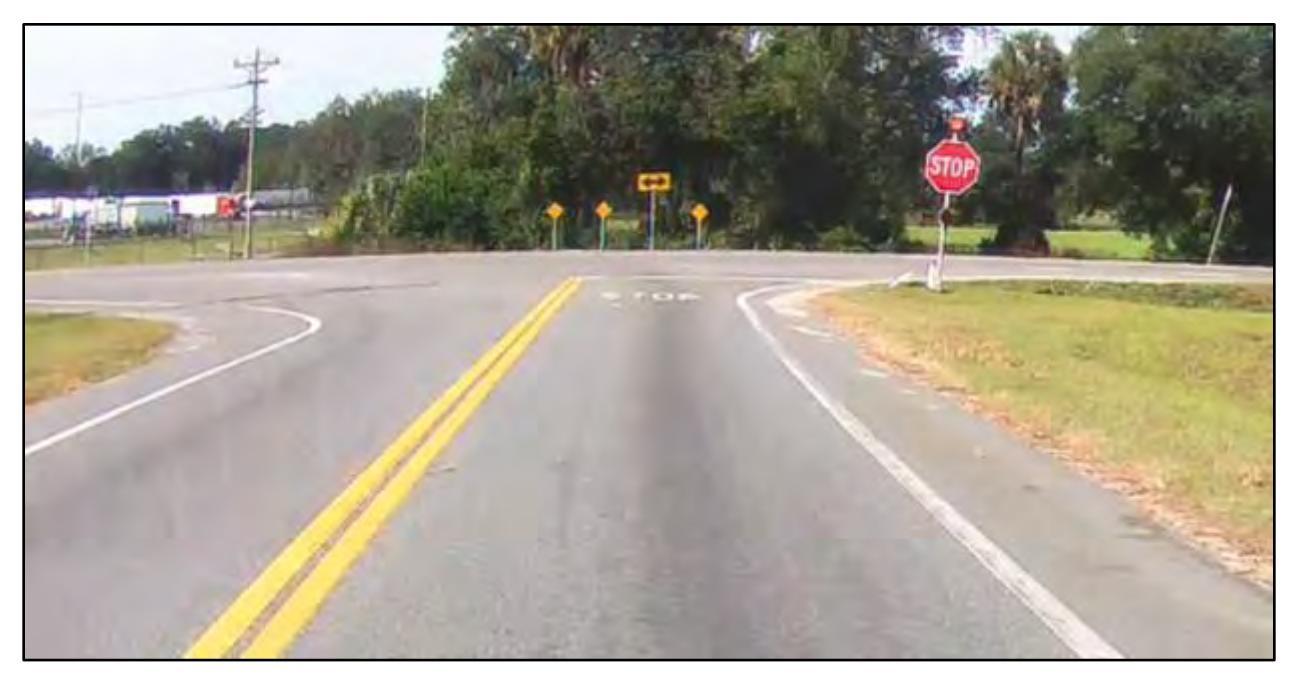
Figure 74. Existing condition of US-41 and SR-238, looking west

Paved shoulder on both roads (Figure 74)

Standard stop sign with flashing beacon on SR-238 (Figure 74)

The intersection existing condition includes an intersection-ahead sign, stop-ahead sign, transverse rumble strips, and stop sign with flashing beacon. The intersection stop sign was installed on 8/2016. Seven crashes occurred at this intersection after this date.

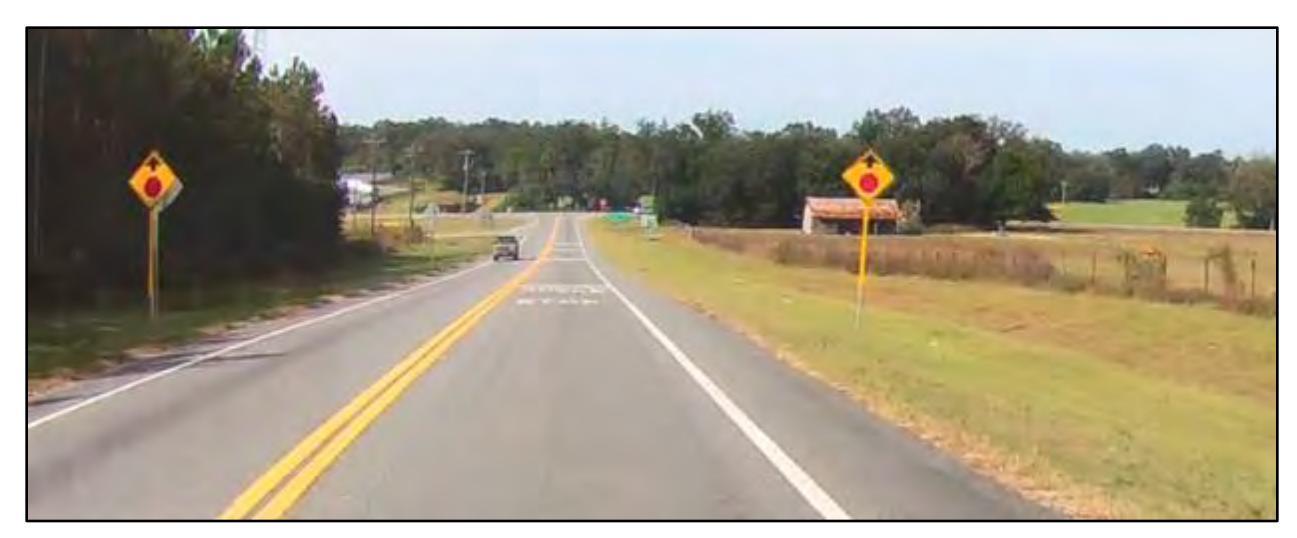
Figure 75. Stop-ahead sign and rumble strips on US-41 and SR-238

Stop ahead sign and intersection-ahead sign on SR-238 (Figure 75)

Standard thermoplastic markings on center- and edge-line Rumble strips on SR-238 (Figure 75)
