Gadsden County Road Safety Study

Summary Report

1/31/2017

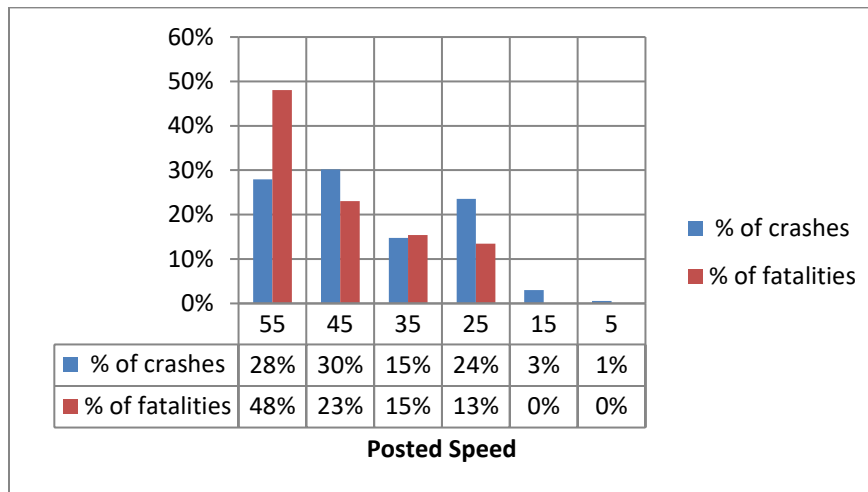
FIGURE 2 POSTED SPEED VS CRASHES (2006 –2015)

As Figure 2 shows, nearly 71% of the fatal crashes on local roads were on roads where the crash report showed a posted speed of 45 mph or greater.
